Punch Inspection Services

Property Inspection Report

1234 Elm Street, Spring, TX 77373
Inspection prepared for: Client Jane
Date of Inspection: 2/4/2016 Time: 9:00 am
Age of Home: 1979 Size: 1596 sq/ft
Weather: Clear
House faces: Northeast
Temperature at arrival: 38 Degrees
Present at inspection: Client/Agent
Occuancy: Vacant

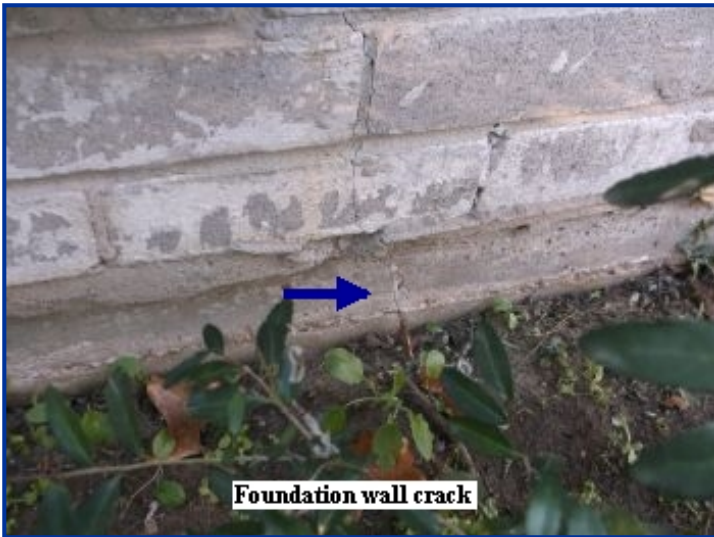
Front elevation

Foundation wall crack

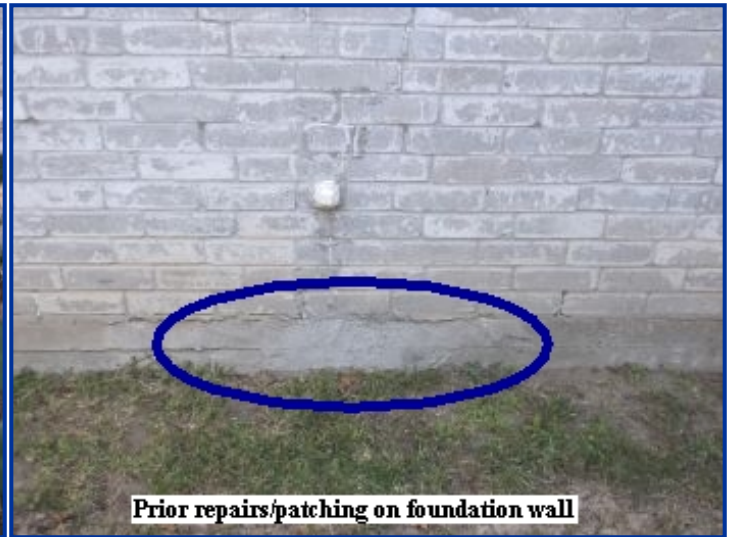
Left elevation of structure

Prior repairs/patching on foundation wall

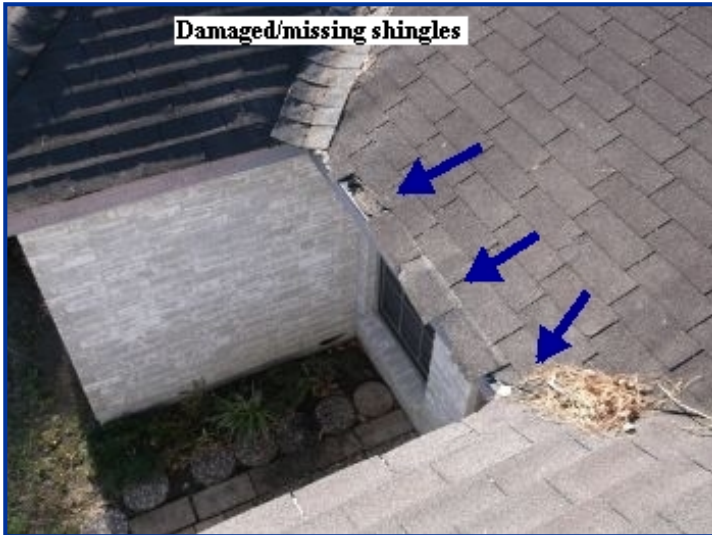
- Shingle damage was observed in various locations (see photos), repairs to the roofing are recommended. Damaged or missing roofing material should be repaired. All roof penetrations should be examined and sealed as necessary.

Front elevation roofing application

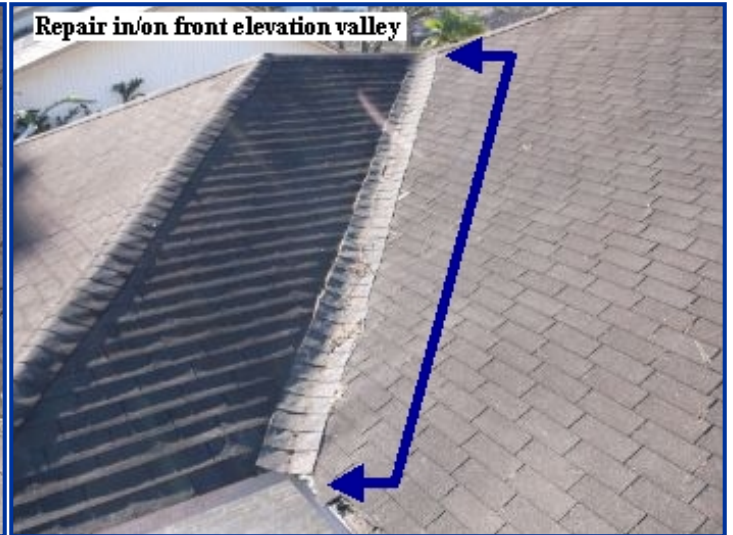
- Note: Prior repairs are present in the front elevation valley.
- Note: The roof application appears to be an overlay to the original installation.
- Repairs to the roofing are recommended. Damaged or missing roofing material should be repaired. All roof penetrations should be examined and sealed as necessary by a licensed and qualified roofing technician.

Roofing application (repair)

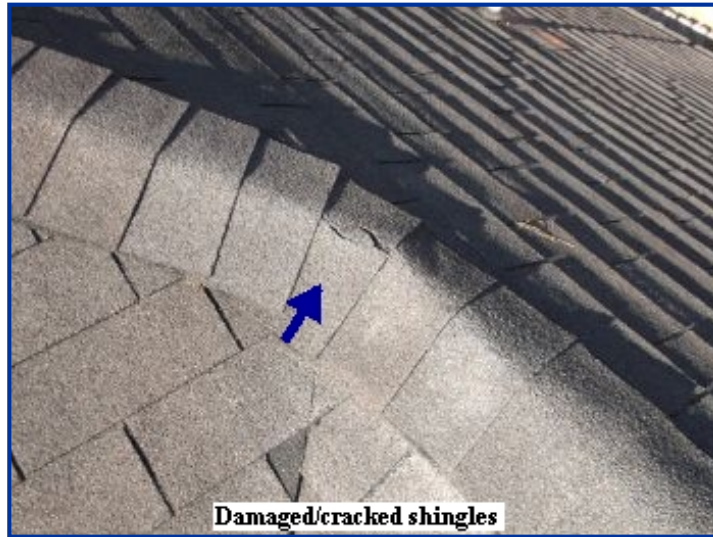
Front elevation ridge/hip transition over garage

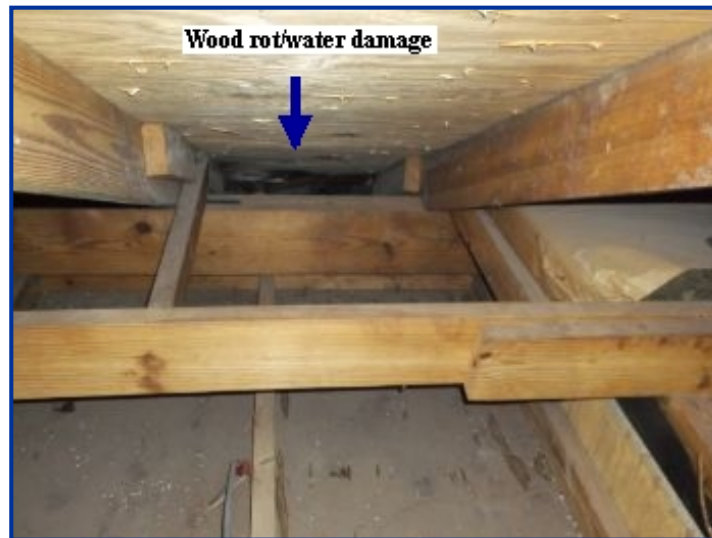
- Wood rot/water damage is present at decking materials over the front porch. Repairs recommended.
- Insulation levels are inadequate by today's standards and insulation is missing in various locations. Further evaluation recommended and repairs/updates as desired.

Decking at eave above front porch

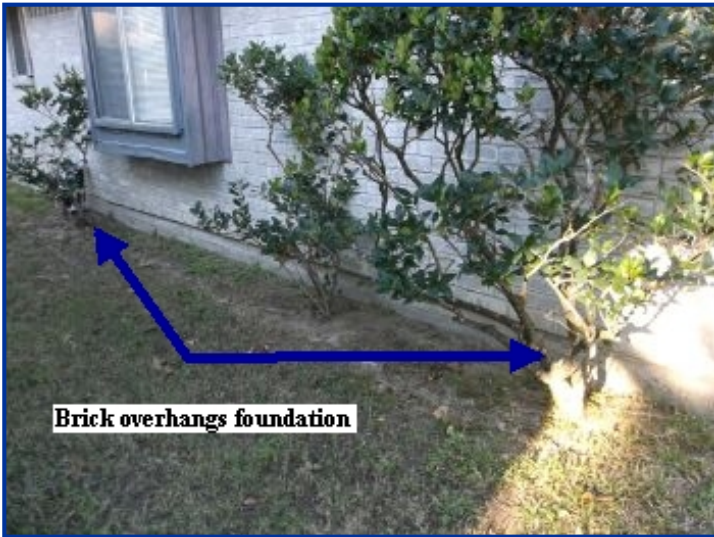
Left elevation masonry application

- The overhang of the brick at the foundation wall, also known as corbelling was observed in the front and left elevations. This could lead to some instability of the brickwork. If movement occurs, re-supporting the brick would be advisable.

Brick overhangs foundation

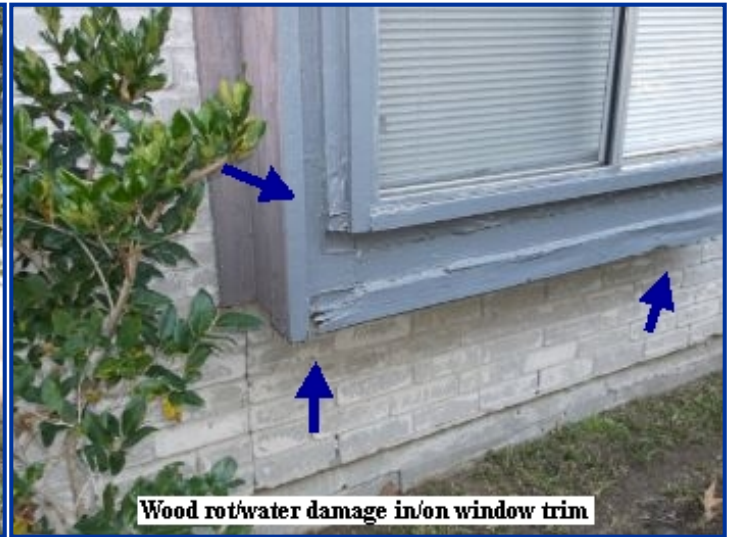
Left elevation box window

Wood rot/water damage in/on window trim

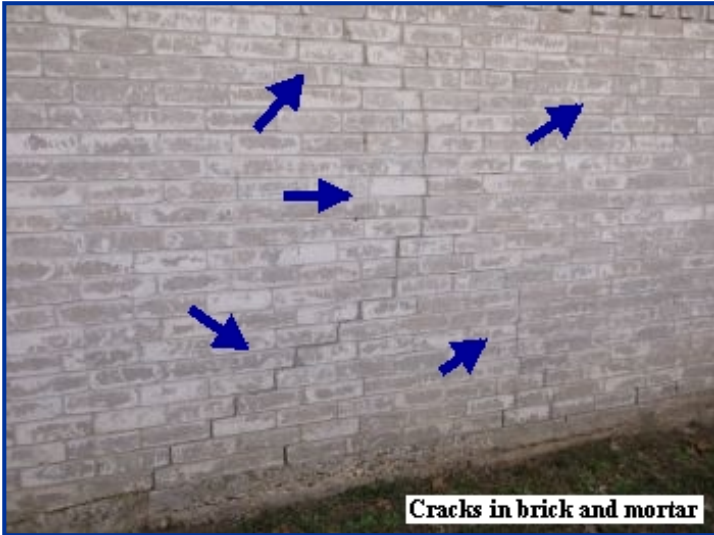
Right elevation masonry application

- Pronounced exterior wall cracks were observed, most notably in the right elevation masonry application. This implies that structural movement of the building has occurred. The rate of movement cannot be predicted during a one-time inspection. A structural specialist should be consulted to further evaluate this condition and the remedies available for correction.

Cracks in brick and mortar

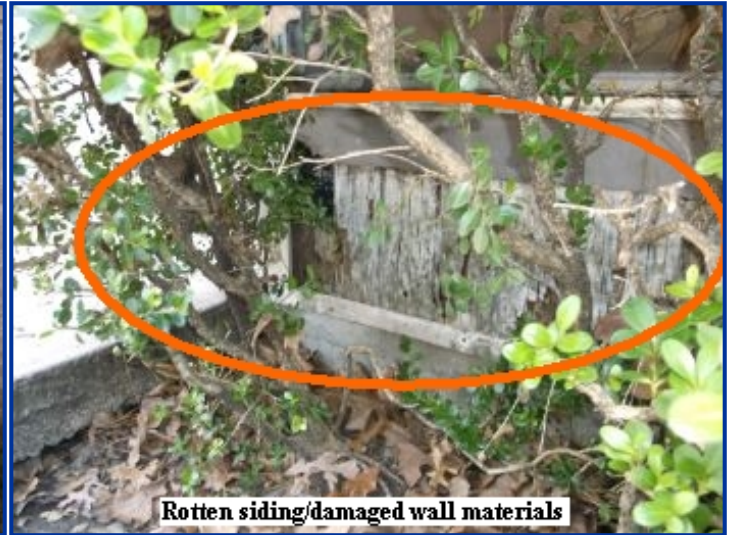
Rear elevation (left) beneath window

- Note: Prior repairs are present in some locations of interior/exterior walls.
- Wood rot/water damage was observed on the exterior wood siding and trim in various locations. Repairs should be undertaken to prevent further damage.

Rotten siding/damaged wall materials

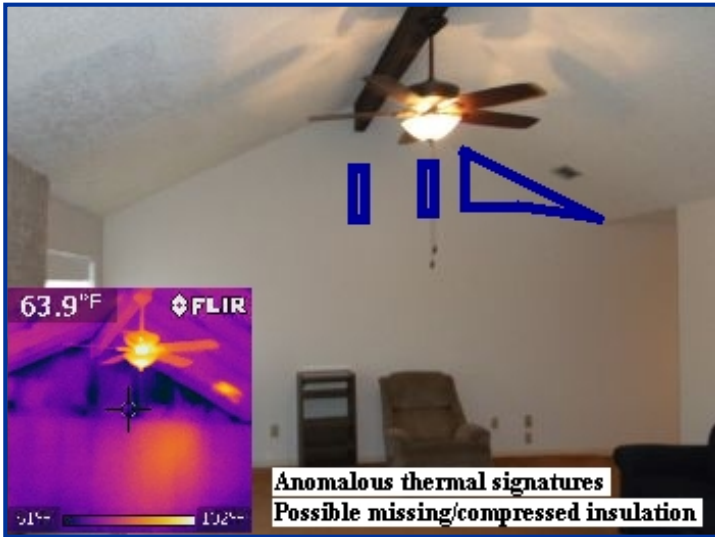
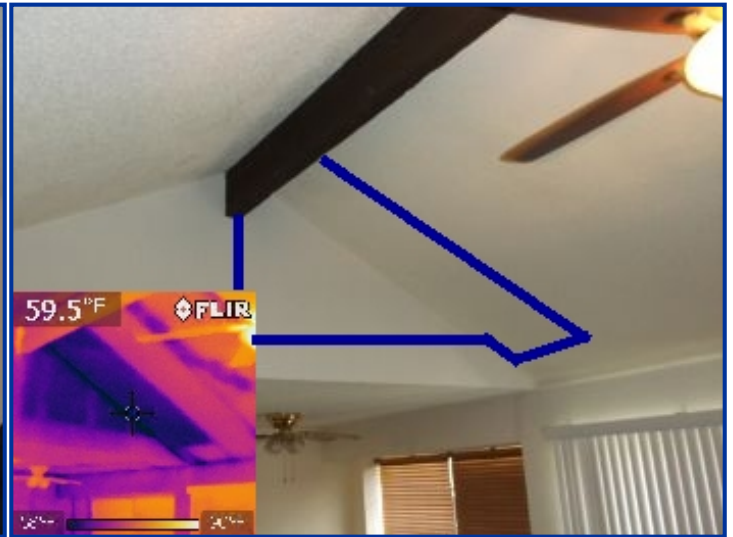
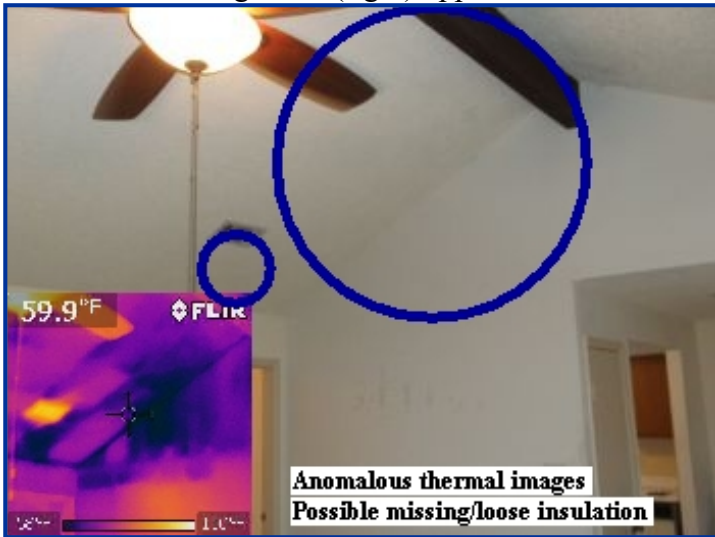
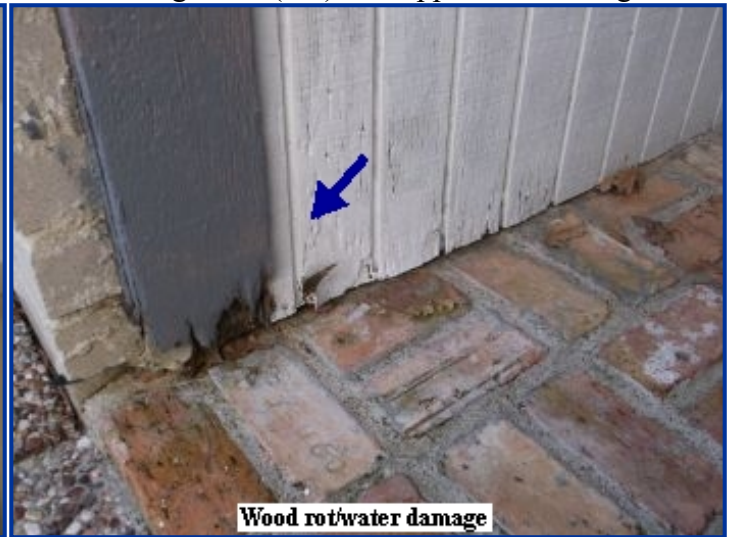
- Observed anomalous temperature signatures with IR imaging in various locations (see photos). Further investigation is recommended and repairs should be undertaken if necessary.

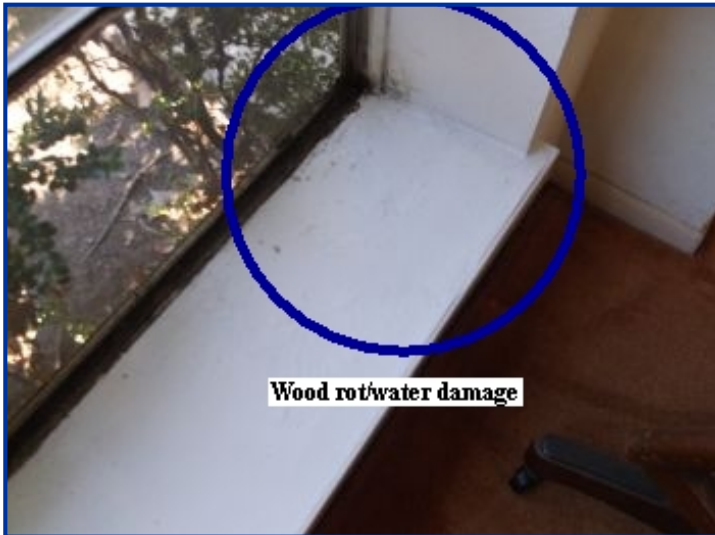
Sill of breakfast window (right)

- Wood rot/water damage is present at the window (right) in the breakfast/dining room. Further evaluation recommended and repairs as needed.
- Minor sheetrock cracks were observed in the house and garage. This condition is mainly cosmetic in nature. Repairs may be desired.

Wood rot/water damage

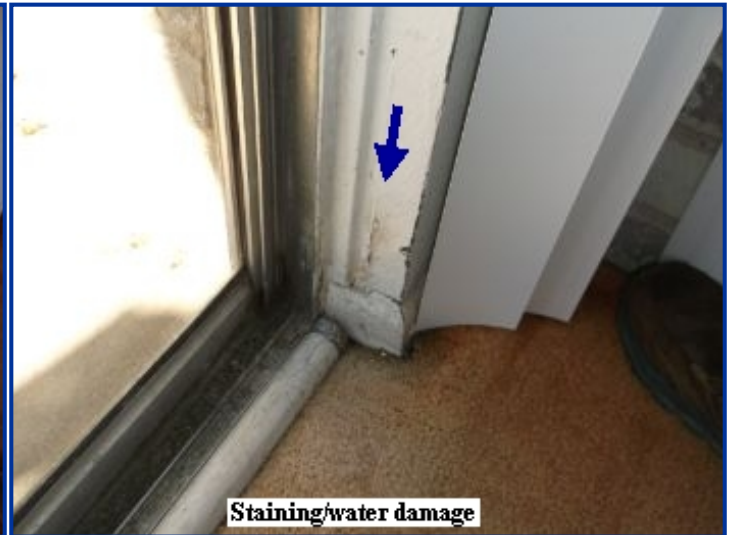
Wall right of sliding glass doors

- Water stains/damage was observed at the right of the sliding glass doors. The cause for the damage should be determined and repairs should be undertaken to prevent further damage as needed.

Staining/water damage

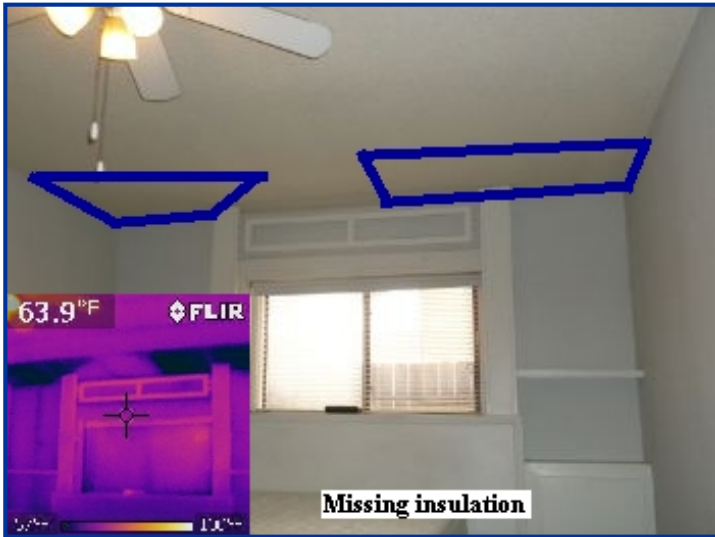
Master bedroom (right) ceiling

Missing insulation

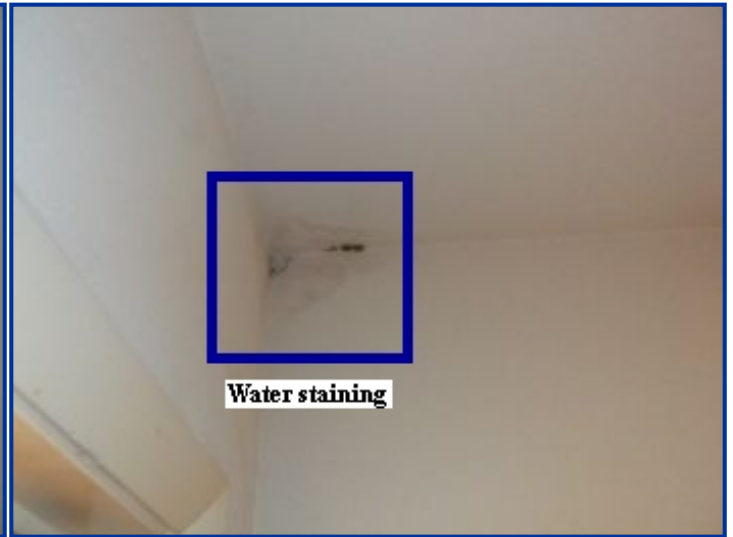
Closet of forward (right) bedroom

- The carpeting in the living room is loose, most notably at the rear wall (right). Repairs recommended.
- Water staining was observed in the closet of the forward (right) bedroom. The cause for the staining should be determined and repairs undertaken, if necessary, to prevent further damage.

Water staining

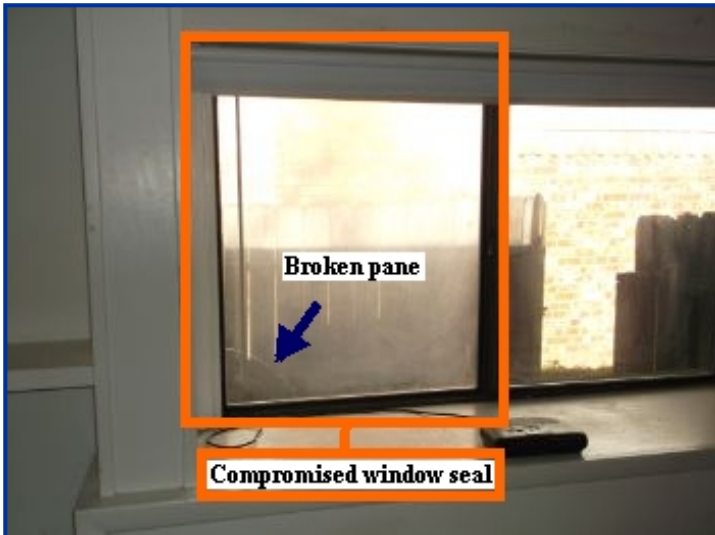
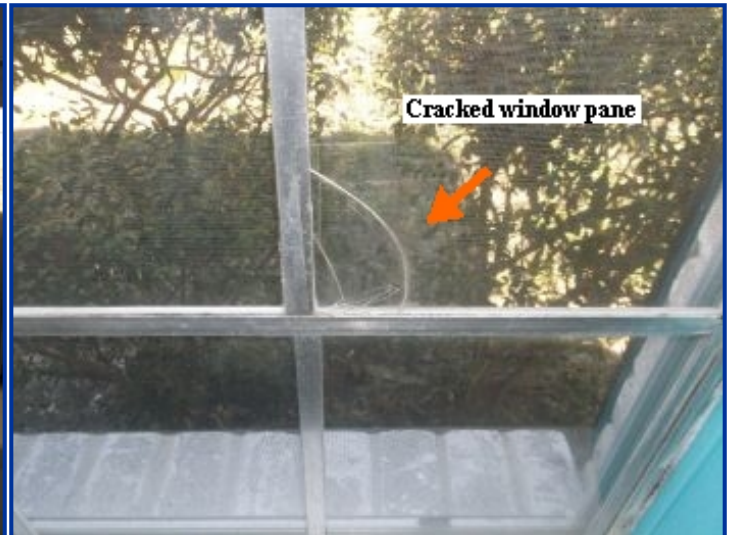
- Missing and/or damaged screens are present. Repairs and/or replacements recommended.
- Broken/cracked glass is present in some windows, most notably in the master bedroom and forward (left) bedroom. Repairs recommended.
- The rear window pane in the master bedroom has lost its seal. This has resulted in a cloudy film developing between the panes of glass and can cause the glass to lose its insulating properties. Replacement recommended.
- Safety glass etchings were not observed on the glass of the window(s) at the front door and the glass above the dog door in the rear of the living room. This glass is required for windows close to the floor or in hazardous locations and is generally identified by an etching in the corner of the glass pane. Repairs recommended for improved safety.
- Loose and damaged window glazings are present. Repairs recommended as needed.

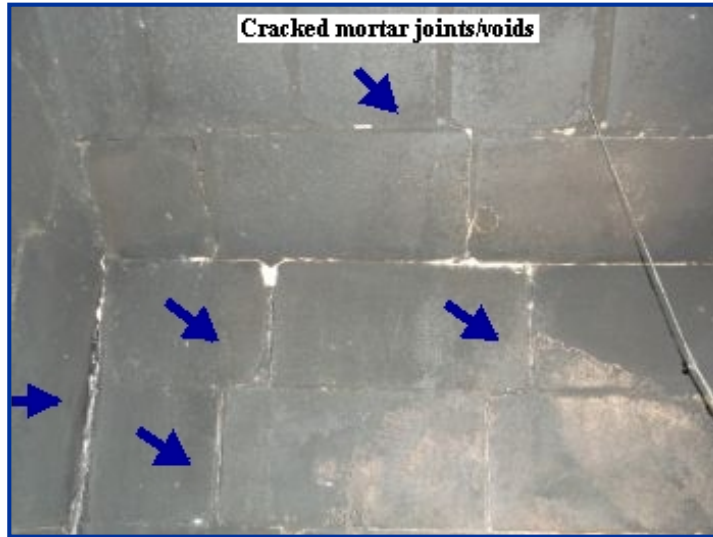
Fireplace firebox

- The fireplace firebox has cracks in the mortar and voids in various locations. Repairs recommended for improved safety.
- Significant creosote build-up was noted in the fireplace flue and/or firebox. Cleaning of these areas is recommended for improved safety.

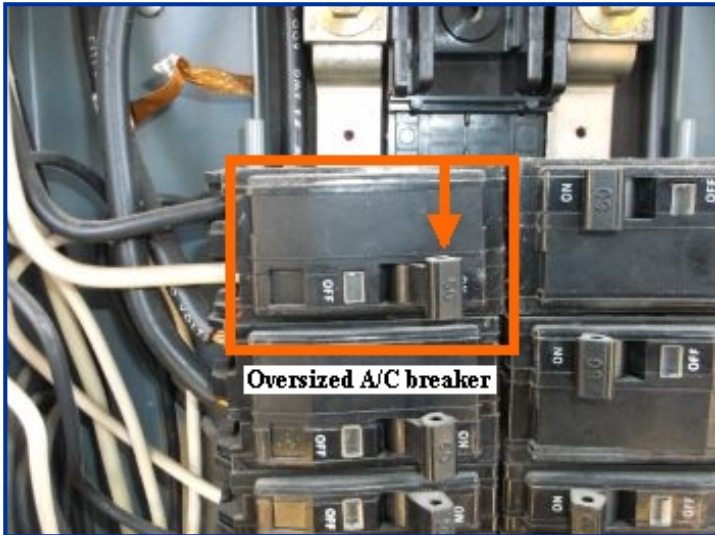
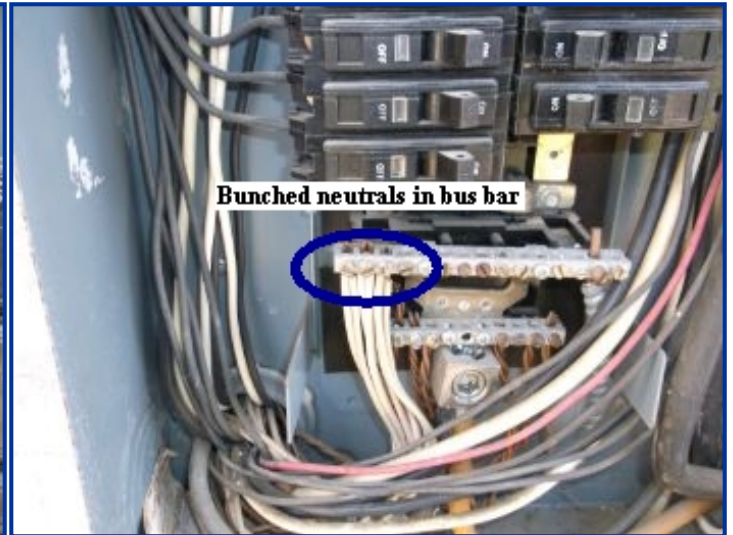
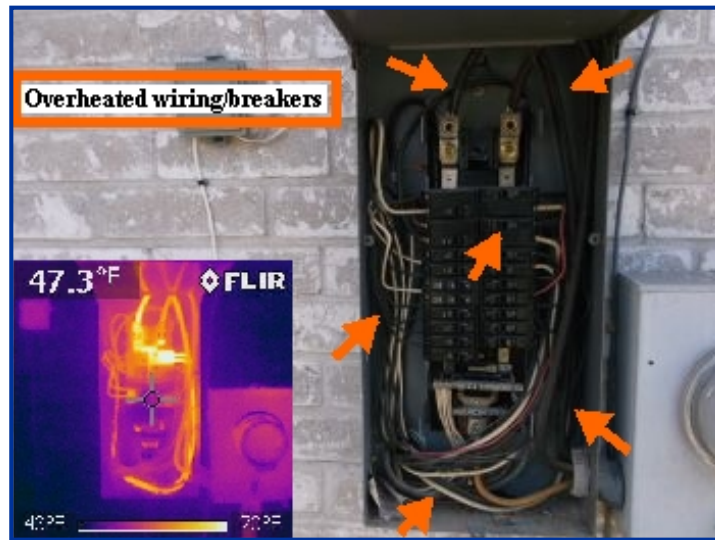
- Antioxidant mastic is not applied to the aluminum main service feed wires to prevent oxidation. Repairs recommended.
- The electrical service panel is not properly labeled. Various breaker designations were unable to be evaluated for proper amperage to equipment/appliances/circuits. Review recommended.

- The electrical service appears to be undersized for this (all electric) house. Further evaluation recommended and repairs if/as needed.
- The breaker serving the A/C is over sized (60amp), the manufacture rates a maximum breaker size of 40amps. Replacing the breaker is recommended.

- Neutral wires within the main distribution panel that are bunched together on the neutral bus bar should be separated. Each wire should be served by a separate screw. Repairs recommended.

- Wiring in the panel appears to be overheating when observed with IR equipment. Further evaluation recommended and repairs if/as needed.

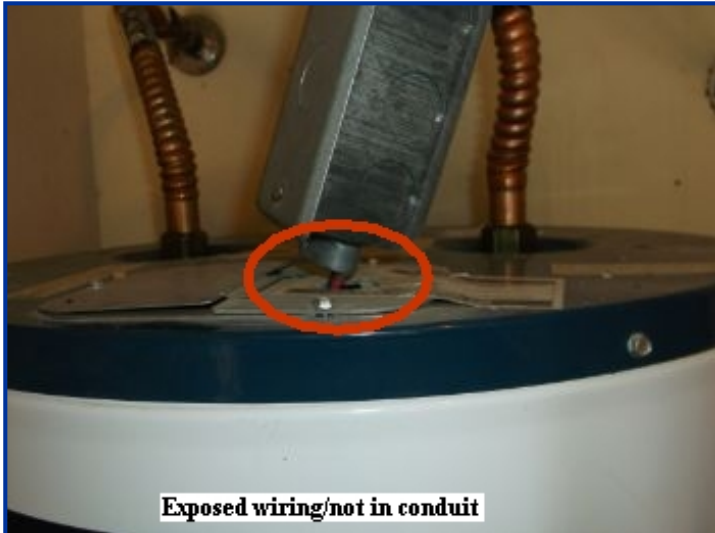
Conductor for water heater

- Conductors for the water heater are not properly enclosed in conduit at the unit and wiring is accessible. Repairs recommended for improved safety.
- The conductor for the disposal is not secured at the clamp. Repairs recommended for improved safety.

Exposed wiring/not in conduit

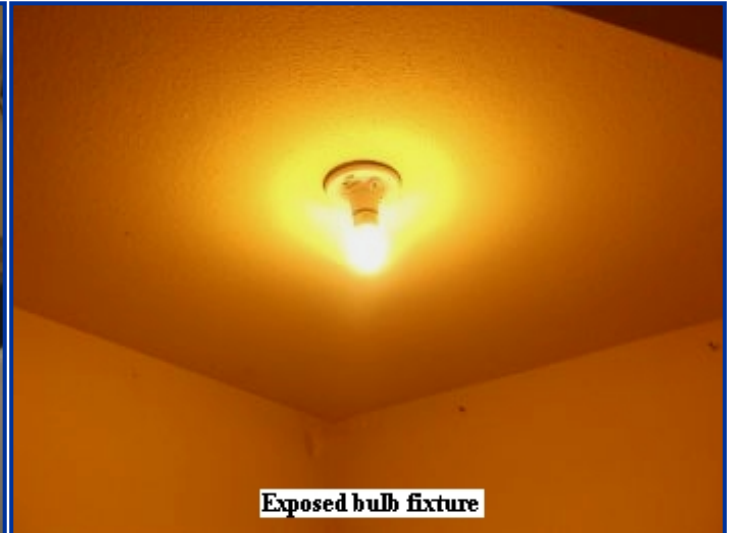
Various locations

- The GFCI outlet in the master bath is not tripping when engaged with a circuit tester. Replacement recommended for improved safety.
- Light fixtures in clothes closets have exposed bulbs. Fixtures globes should be installed for fire prevention purposes.

Exposed bulb fixture

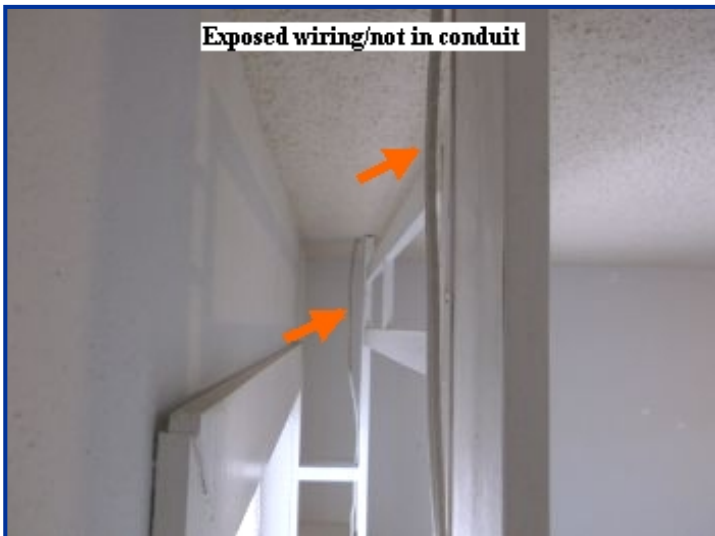
Master bedroom

- The fan/lights in the dining/breakfast room were unable to be operated with normal controls. Repairs recommended for proper operation.
- Exposed wiring is present in the master bedroom. Accessible wiring should be installed in conduit. Repairs recommended for improved safety.

Exposed wiring/not in conduit

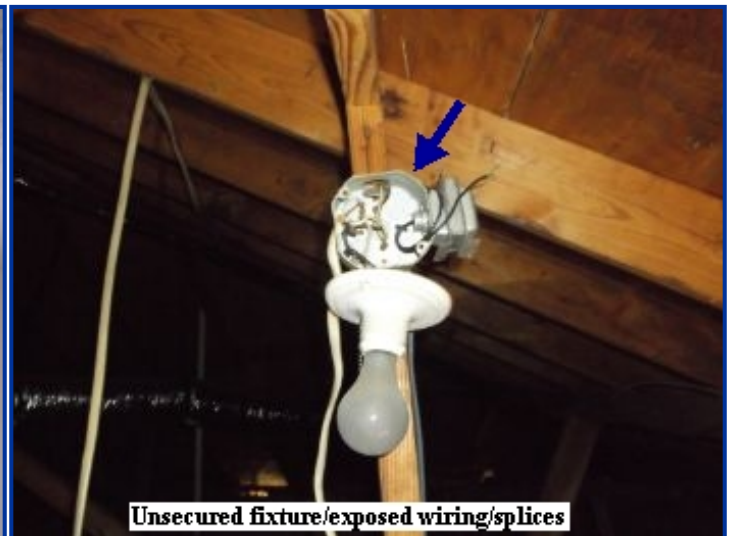
Attic light

- Expose wire splices are present in various locations of the attic, most notably for the power attic fan, over the front porch, above the forward wall of the living room (left side), and at the attic light. Repairs recommended for improved safety.

Unsecured fixture/exposed wiring/splices

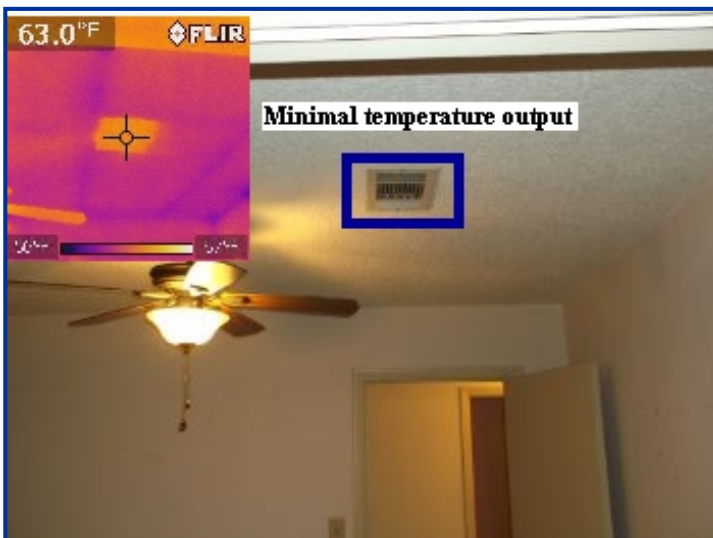
Register in forward (right) bedroom

- Filter is located in the right hall (18x36)
- The air output at the register in the forward bedroom (right) is significantly less than the aggregate of all other registers. Further evaluation recommended by licensed HVAC contractor and repairs as needed.

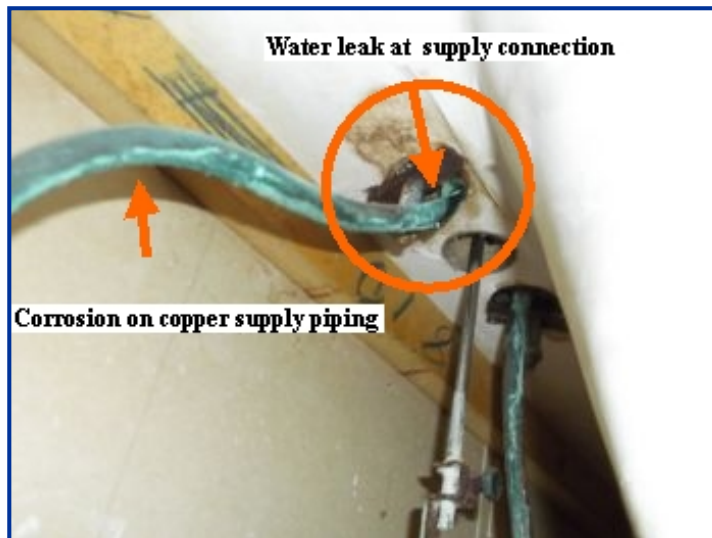
Master bath sink (right)

- Anti-siphon/back-flow prevention device(s) are not installed on exterior faucet(s). Repairs recommended for improved safety.
- A constant drip is present at the master bath tub spout. Repairs recommended.
- The left sink in the master bath is missing an aerator and water is spraying onto the counter top during operation. Repairs recommended.
- A supply line is leaking beneath the left sink in the master bedroom during operation. Repairs required to protect against damage to cabinet and stored items below.
- The master shower head is leaking at the connection. Repairs recommended.
- Corrosion is present on copper piping in some areas, most notably beneath the master bath sinks. Further evaluation recommended and repairs as needed.
- Rust/corrosion is present on bath faucets in the home. Further evaluation recommended and repairs if/as needed.

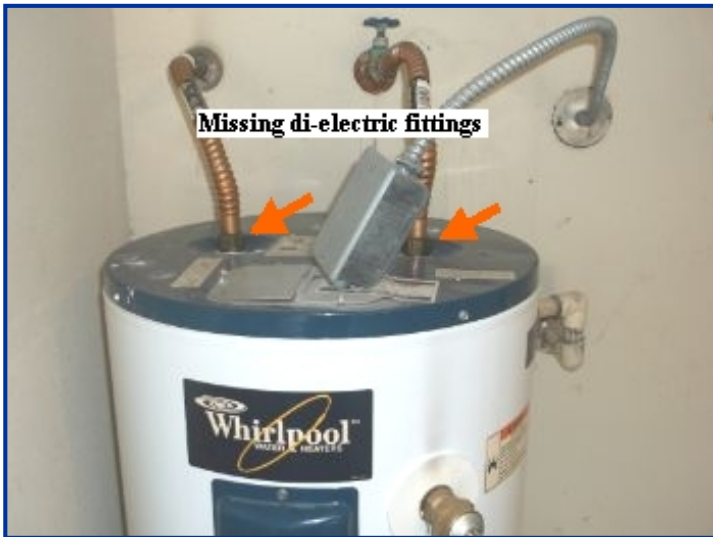
- An electrical disconnect is not supplied for the electric water heater. Updating recommended.
- Dielectric fittings do not appear to be installed for the water heater supply/discharge lines. Repairs recommended for improved safety.

Water heater supply/discharge lines

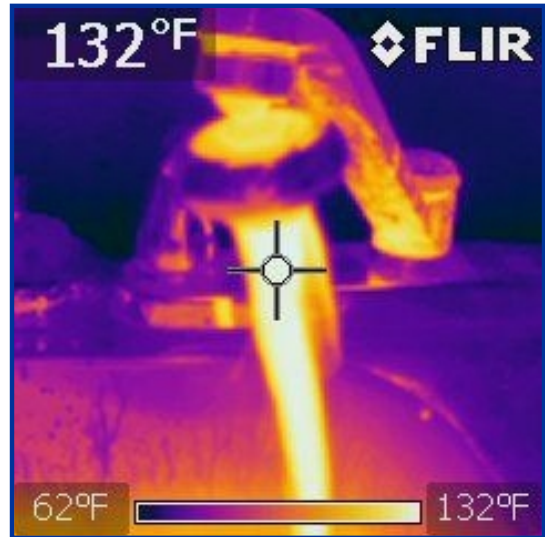
- The water temperature was measured at 132 degrees which is not within acceptable limits to prevent the potential for scalding of 120 degrees. Adjustments to setting recommended.

Excessive water temperature
