Punch Inspection Services

5150 Wisteria Lane, The Woodlands, TX 77XXX Inspection prepared for:

Date of Inspection: 10/22/2014 Time: 9:00 am Age of Home: 2014-2015 Size: 3380 sq/ft Weather: Clear

PROPERTY INSPECTION REPOR	<u> </u>
(Name of Client)	
5150 Wisteria Lane, The Woodlands TX	X, 77XXX
(Address or Other Identification of Inspected Prop	perty)
Michael Missler, TREC License #8902	10/22/2014
(Name and License Number of Inspector)	(Date)
(Name and License Number of Sponsoring Inspector)	
	(Name of Client) 5150 Wisteria Lane, The Woodlands To (Address or Other Identification of Inspected Proposition of Michael Missler, TREC License #8902

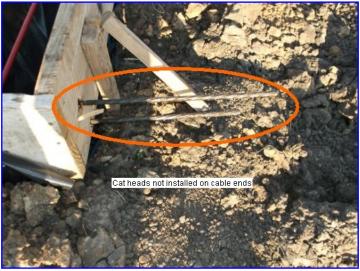
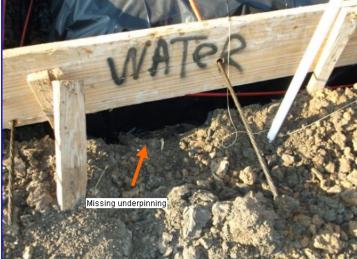
- "Cat Heads" are not installed on the post tension cable ends. Installation recommended to prevent potential for the cables to pull back into the form during concrete install.

- Underpinning is missing in some locations, most notably in the right elevation near the water line. Repairs are typically undertaken during concrete install.

- Form floats for the porches and garage are not installed during this inspection. Repairs required prior to concrete install.
- Brick ledge form boards are not installed during this inspection. Repairs required prior to concrete install.

- Minor voids are present in the poly joints. Repairs recommended.
- Minor amounts of debris and clumps of mud are present in the base of some beams, most notably in the far right beam. Removal recommended prior to concrete install.

- The left elevation form boards do not appear the be installed at the proper length. The beam detail indicates the forms should measure 62' 10 1/2" from front to rear. The measurement observed during the inspection is 62' 7 1/2". Further evaluation recommended and repairs as needed.

- Upper reinforcement rebar in the rear elevation of the form (right of the bay window) has become unsecured and one end is resting in the base of the beam. Repairs recommended.

- The beam depths of the porches and garage slopes do not appear to be correct. The beam detail indicates beams to be 30" in depth. Further evaluation recommended and repairs as needed.
