Punch Inspection Services **Property Inspection Report**

4321 Rodeo Drive, The Woodlands, TX 77XXX
Inspection prepared for: Punch Frame Demo
Date of Inspection: 4/18/2015 Time: 11:00 am
Age of Home: 2015 Size: 4,167 sq/ft
Weather: Overcast/Rain
House faces: West
Temperature at arrival: 76 Degrees
Occupancy: Vacant

PROPERTY INSPECTION REPORT

Concerning: 4321 Rodeo Drive, The Woodlands TX, 77XXX
 (Address or Other Identification of Inspected Property)

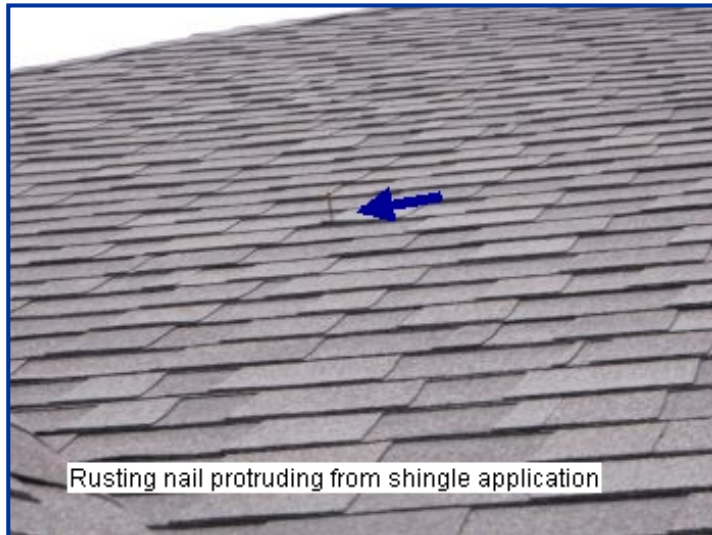
Rear elevation roofing application

Rusting nail protruding from shingle application

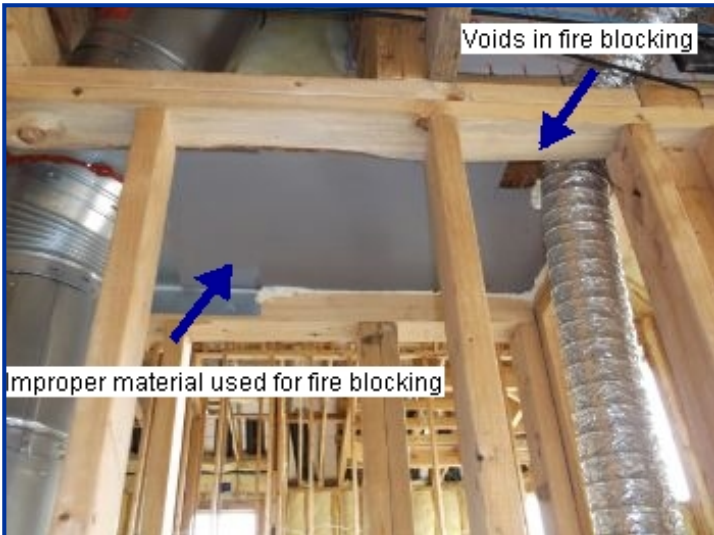
Fireplace flue chase

- Viewed From: Attics
- Ventilation observed: Soffit and Ridge
- Note: Windstorm bracing requirements differ according to location and vary in scope. Windstorm bracing was not evaluated for compliance during this inspection.
- Note: Upper cabinet blocking is not installed in the kitchen. Further evaluation recommended and repairs as needed.
- Voids are present for the fireplace flue chase and improper materials have been installed as fire blocking. Repairs recommended for proper safety.
- Fire blocking is missing in various locations, most notably for the chase at the bottom of the stairs and the chase in the upper level at the right of the stairwell. A complete review of all chases is recommended and repairs as needed for proper safety.
- Upper ventilation has not been installed for the front and rear porches that share common walls with the home. Repairs recommended.

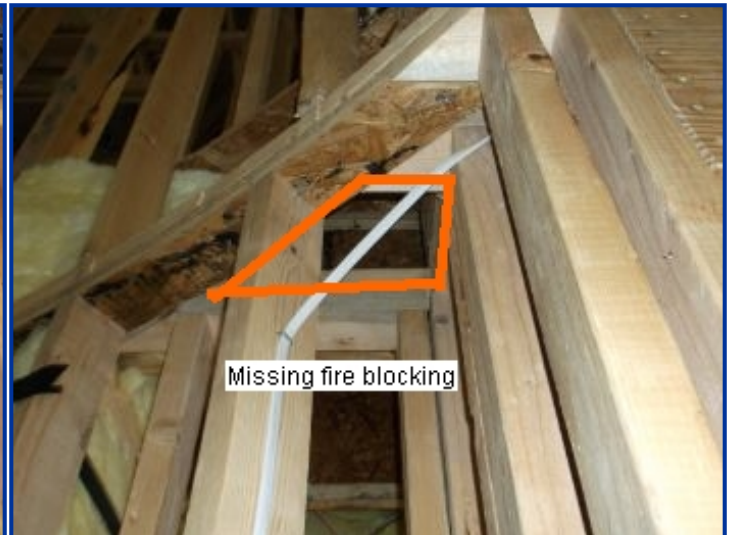
Chase at base of stairs

- Framing at the right of the stairs appears incomplete in various locations in both the upper and lower levels of the home. Further evaluation recommended and repairs as needed prior to sheetrock installation.

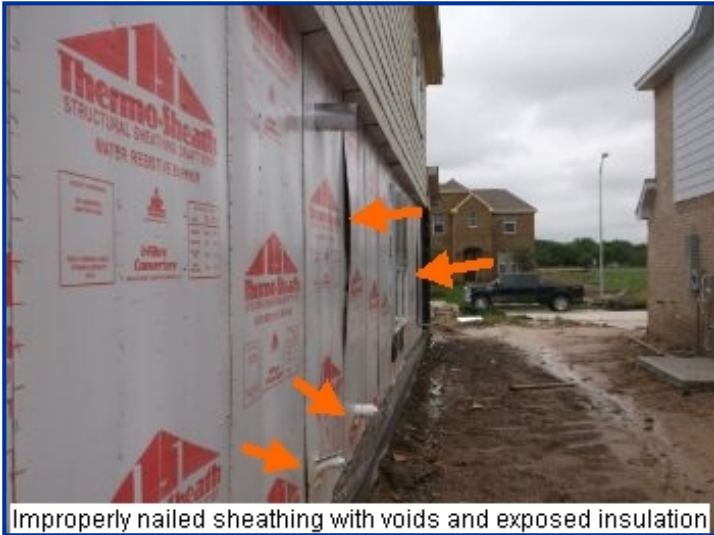
Left elevation exterior

- Sheathing penetrations, voids, exposed raw wood, and improper nailing was observed in various locations of the exterior sheathing applications. A complete review of all exterior sheathing recommended and repairs as needed for proper vapor barrier and structural integrity.

Improperly nailed sheathing with voids and exposed insulation

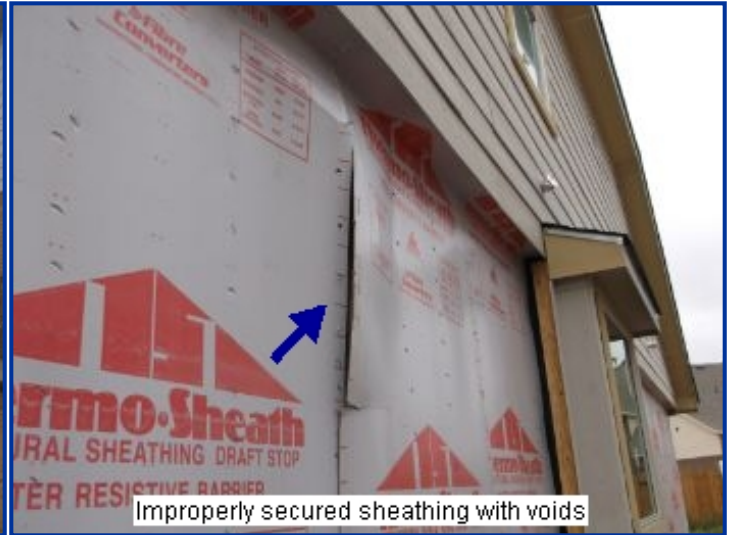
Right elevation exterior

Improperly secured sheathing with voids

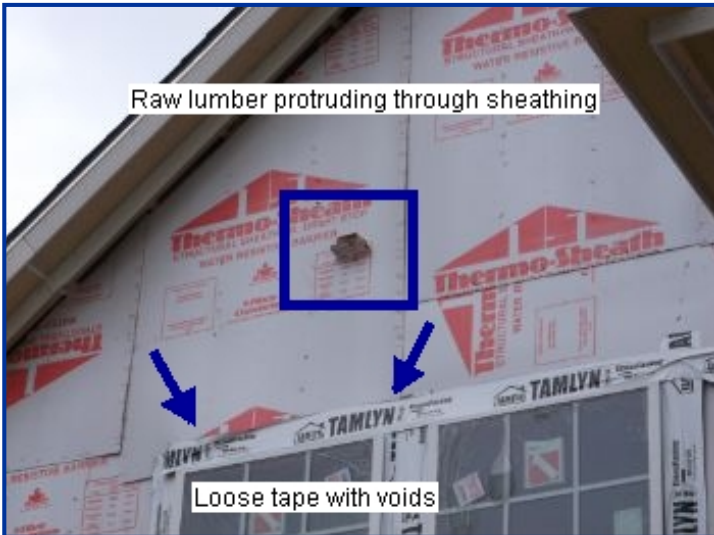
Front elevation gable over porch

Raw lumber protruding through sheathing

Loose tape with voids

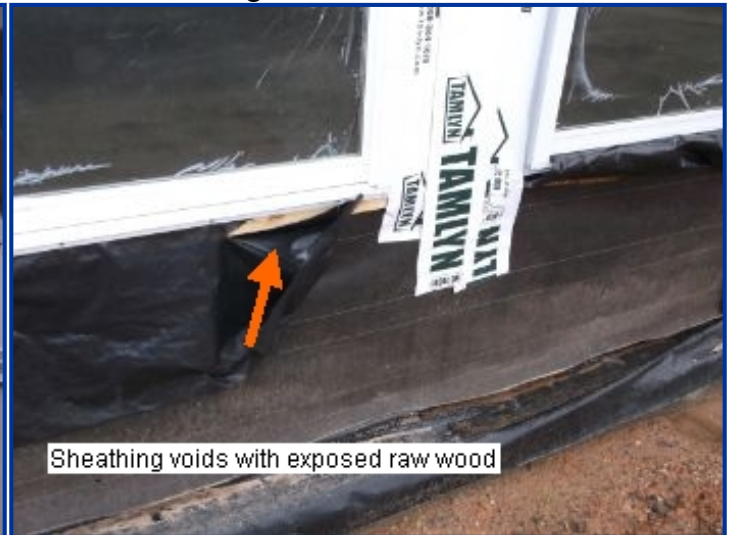
Rear elevation exterior

Sheathing voids with exposed raw wood

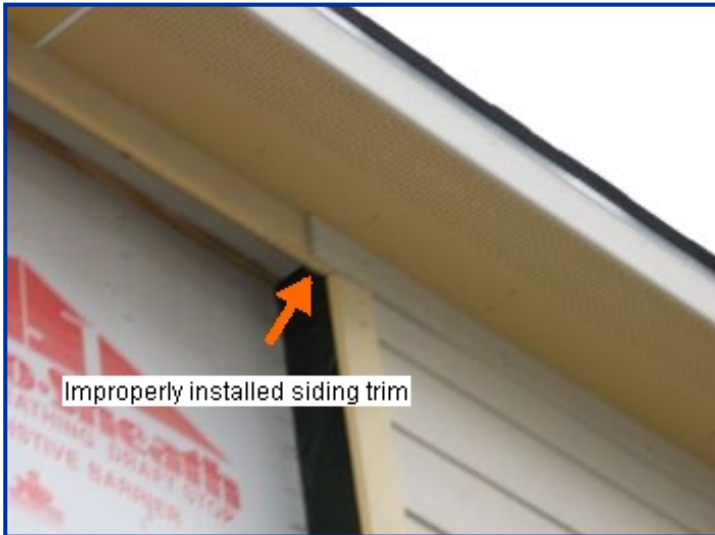
Right elevation siding trim

- Siding trim is improperly overlapped in the right elevation (soffit transition) near the brick frieze trim. Repairs recommended.
- Nail guards are missing in various locations for plumbing and electrical rough in materials, most notably in the right wall of the garage. A complete review is recommended and repairs as needed to prevent potential for damage during installation of other materials.

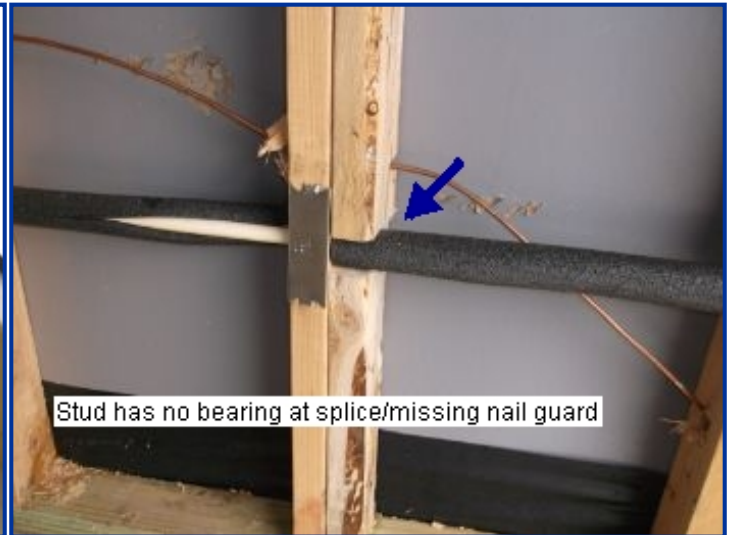
Garage (right wall)

- Wall framing (studs) in the right wall of the garage have complete voids/no bearing to the bottom plate. Repairs recommended for proper support of all framing materials above this location.

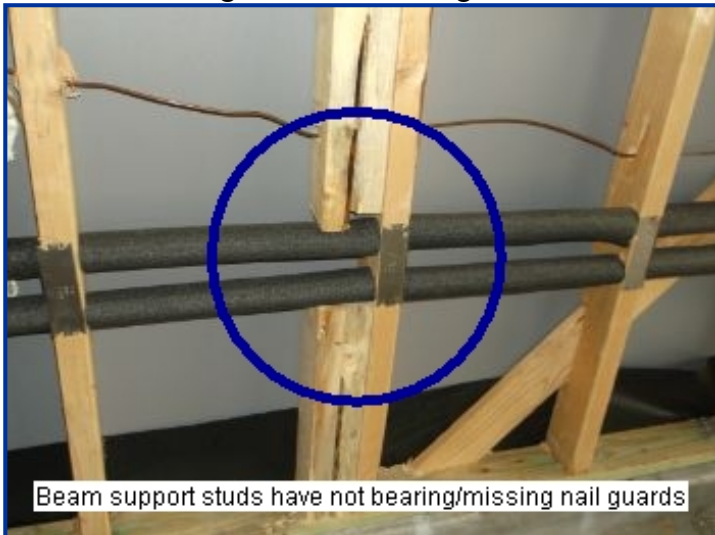
Garage (right wall)

- The studs width is improper below a double joist in the garage framing. Studs should be (at minimum) the width of the joist that is supported. Repairs recommended for proper load transfer.

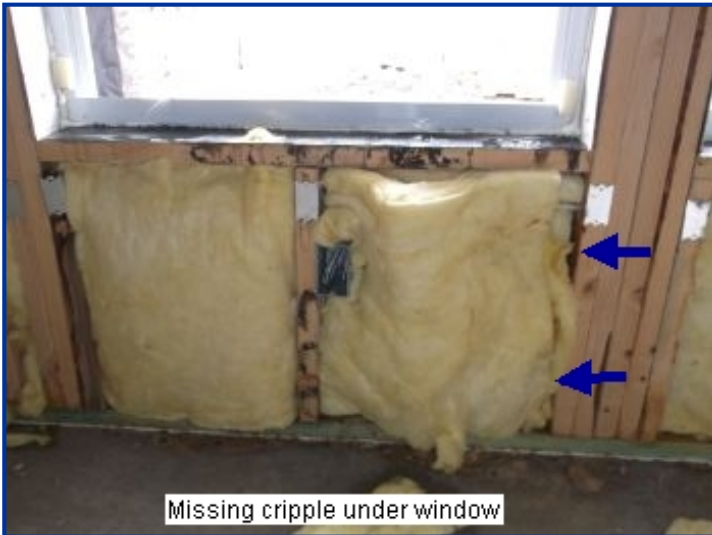
Left window of lower level (left front) room

- A cripple is missing beneath the left window installed in the lower level (forward left) room. Repairs recommended.
- Cripples are not installed beneath a beam in the upper left wall of the living room framing. Repairs recommended for proper load transfer.

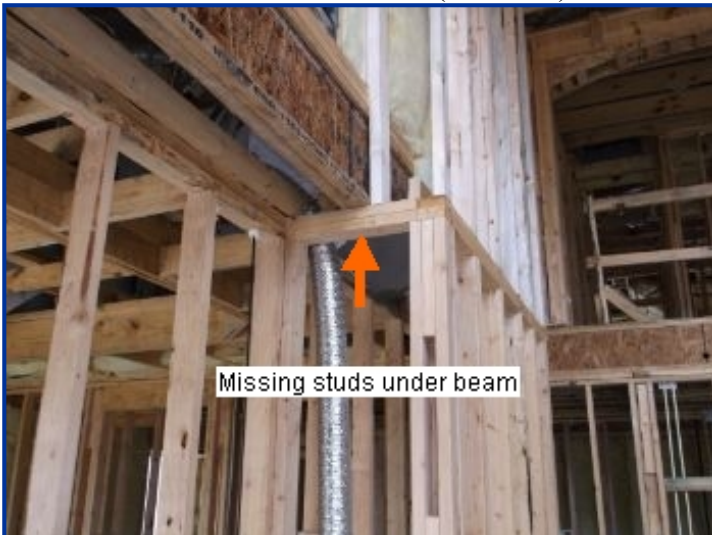
Left side of fire box

- Studs are not installed beneath the beam at the left side of the fireplace framing. Repairs recommended for proper load transfer.
- The duct installed in the closet of the upper left hall is exposed (missing fur-out materials). Additional framing recommended.

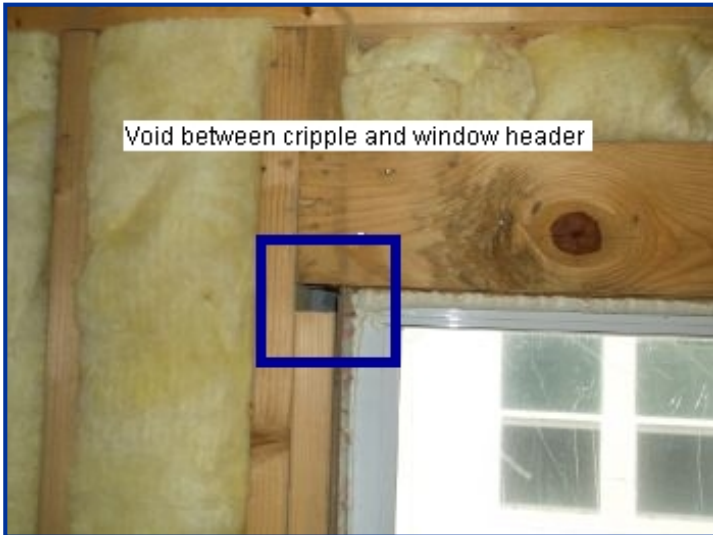
Upper level game room (forward window)

- Voids are present between cripples and headers in various locations, most notably at the forward window of the upper level game room. Shimming/repairs recommended to prevent potential for excessive settling.

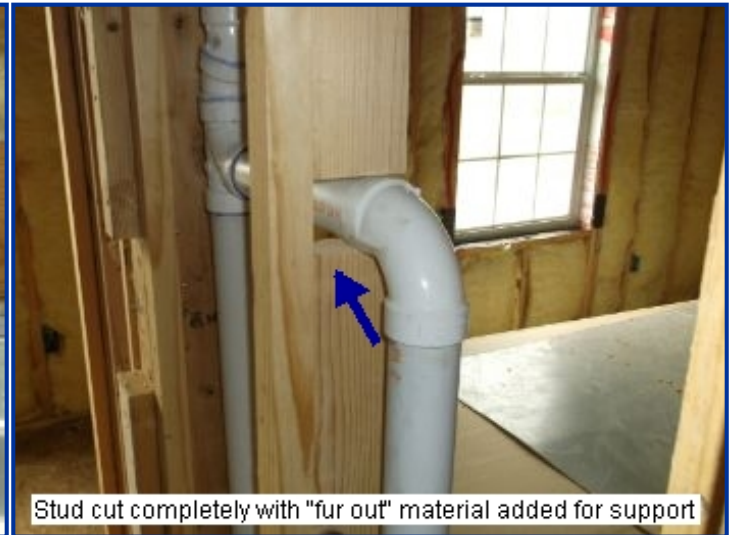
Upper level (right forward) bath

(forward right) bath and "fur out" materials have been added for support. Further evaluation recommended and repairs as needed.

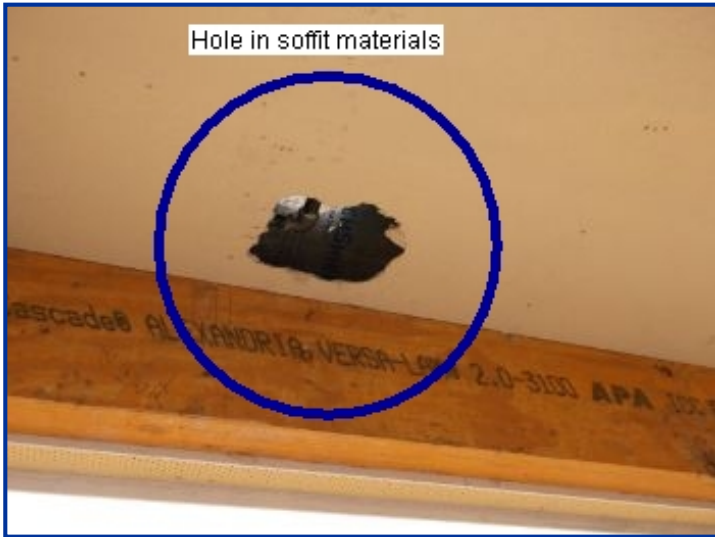
Rear porch ceiling

- Note: Some portions of the ceiling framing were not visible as insulation has been installed for this home.
- A void is present in the soffit of the rear porch. Repairs required.

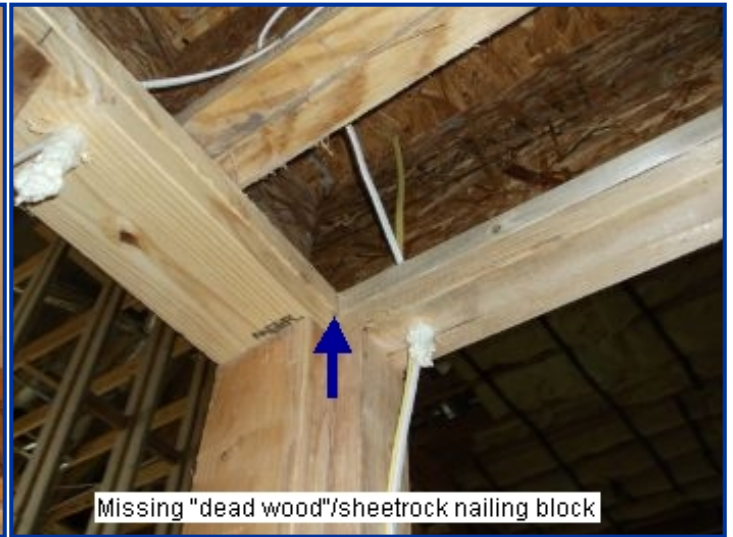
Various locations

- "Dead wood"/sheetrock nailers are missing in various locations. A complete review of and interior and exterior ceiling corners is recommended and repairs as needed prior to sheetrock installation.

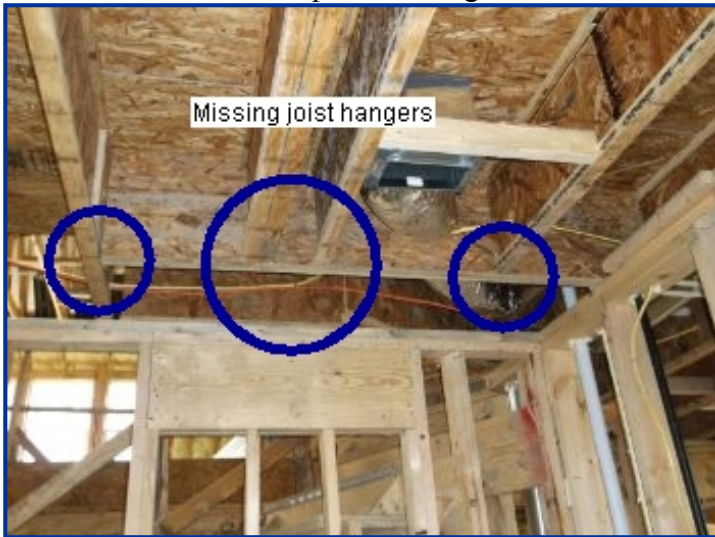
Master closet

- Joist hangers are not installed for joists over the master closet and master bath commode areas. Repairs recommended for proper load transfer.
- A joist hanger is missing for a joist in the upper (forward left) corner of the living room. Repairs recommended.

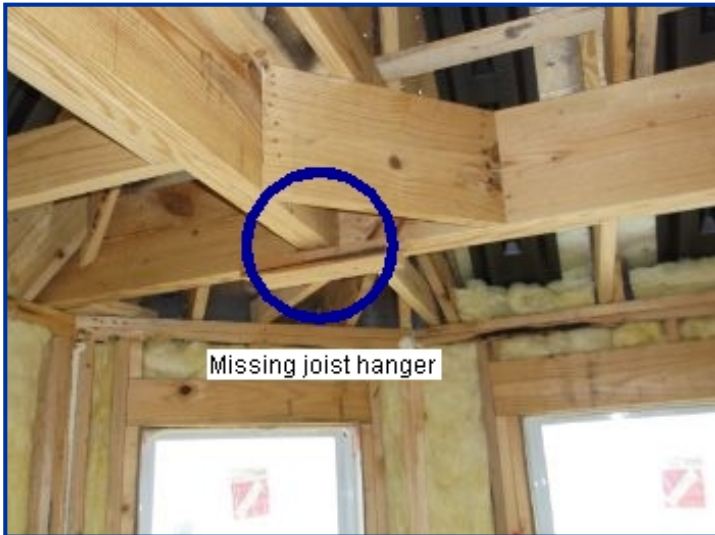
Upper level (rear left) bedroom

- A joist hanger is not installed in the ceiling framing (rear left) of the upper level rear left bedroom. Repairs recommended.
- Joist hangers are not installed (6) for joists above the left side of the overlook in the upper level. Repairs recommended for proper load transfer.

Missing joist hanger

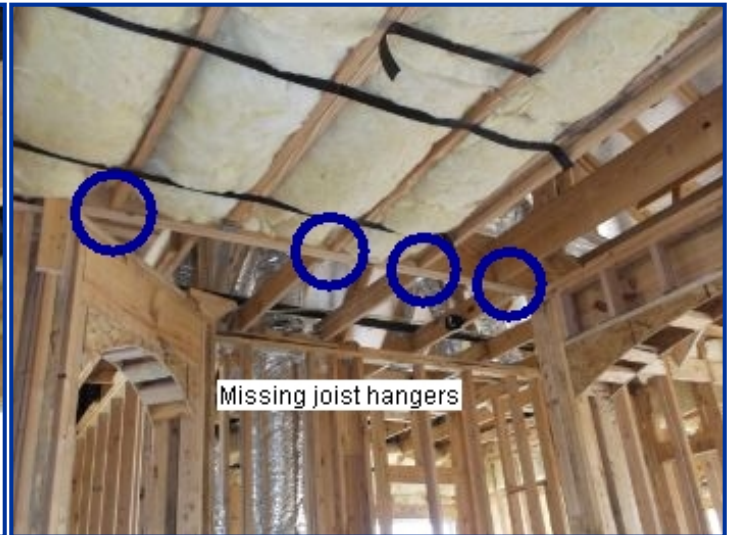
Left side of upper level (overlook hallway)

Missing joist hangers

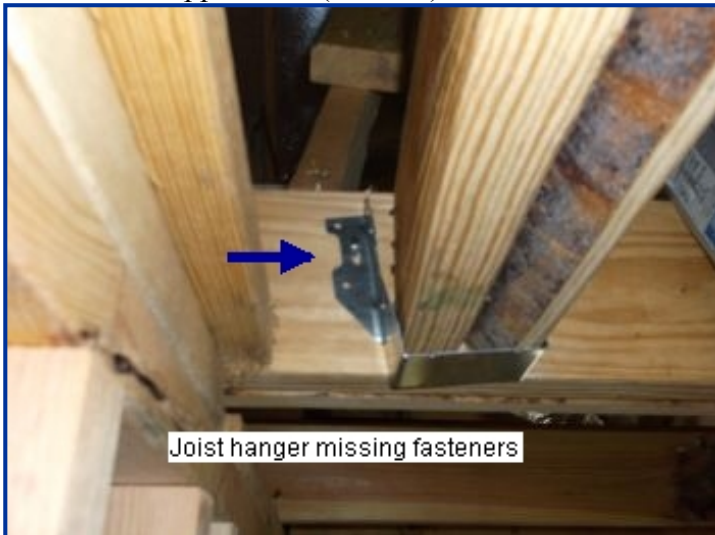
Attic stair framing

- Joist hangers installed for the attic stair framing are missing nails/fasteners. Repairs recommended.
- Various "floating" beams are installed without proper strut bracing to prevent potential for "racking"/twisting. Repairs recommended.

Joist hanger missing fasteners

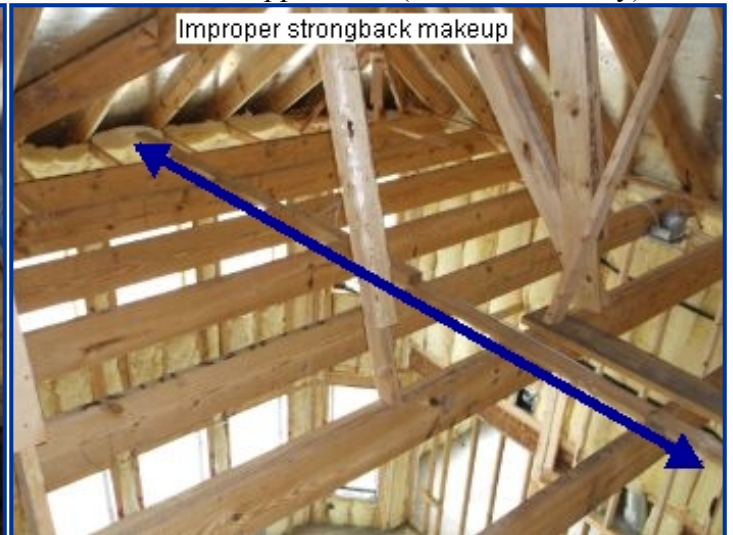
- Various strong back bracing is installed with improper construction and/or improperly blocked and tied at the ends. Further evaluation recommended and repairs as needed.

Improper strongback makeup

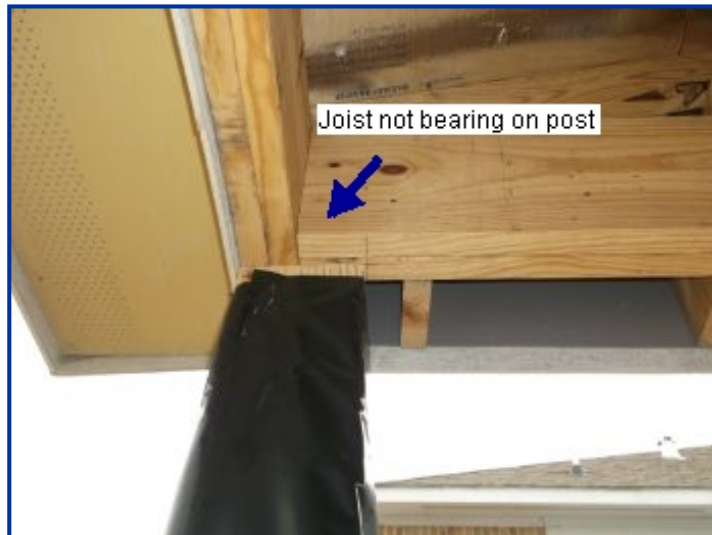
Front porch (left post)

- The joists supporting the left side of the front porch do not have full bearing on the post below. Repairs recommended for proper load transfer.

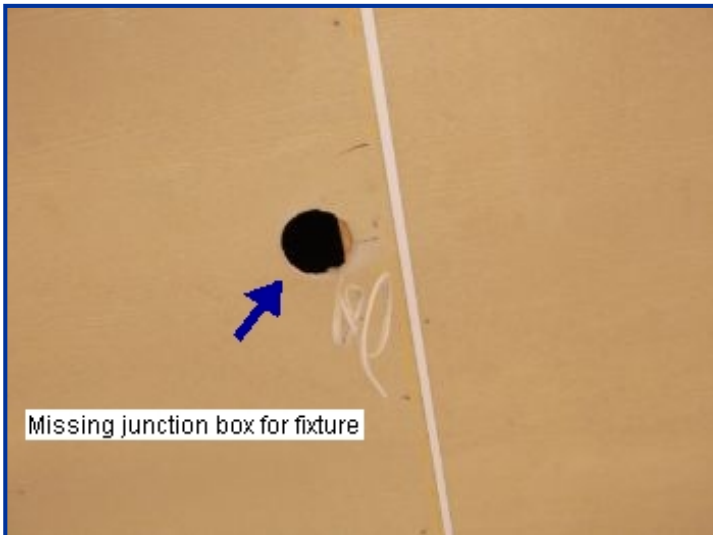
Rear porch ceiling electrical stub

- A junction box is not installed for the rear porch wiring stubbed for a fixture in the center of the ceiling. Repairs recommend.
- Wiring is installed out of the wall plane in the master bath near the rear sink area. Repairs recommended prior to sheetrock installation.
- A switch junction box in the hall outside the master bedroom is unsecured and has no access through framing. Repairs recommended prior to sheetrock installation.
- A junction box is not secured to wall framing in the upper level (left rear) bath. Repairs recommended prior to sheetrock installation.
- Nail guards are missing in various locations, most notably in the right wall of the garage. Repairs recommended prior to sheetrock to prevent potential for damage from the installation of other materials.

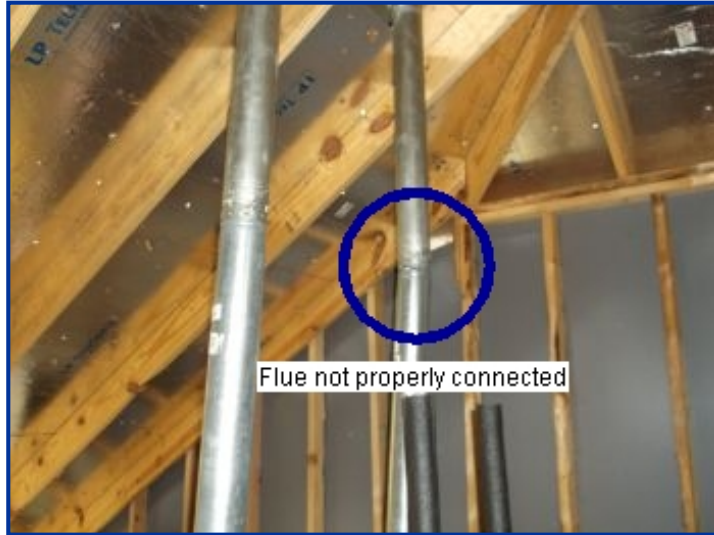
Right side water heater flue

- The flue for the right side unit is incorrectly secured at a joint. Repairs recommended to prevent potential for combustion air leakage into attic once operable.
