Property Inspection Report

21 Jump Street, Katy, TX 774XX
Inspection prepared for: Punch New Home Demo
Date of Inspection: 12/18/2014 Time: 8:00am
Age of Home: 2014 Size: 4800 sq/ft
Weather: Overcast/rain
House faces: Northwest
Temperature at arrival: 60 Degrees
Present at inspection: Client
Occupancy: Vacant

Concerning: 21 Jump Street, Katy TX, 774XX
 (Address or Other Identification of Inspected Property)

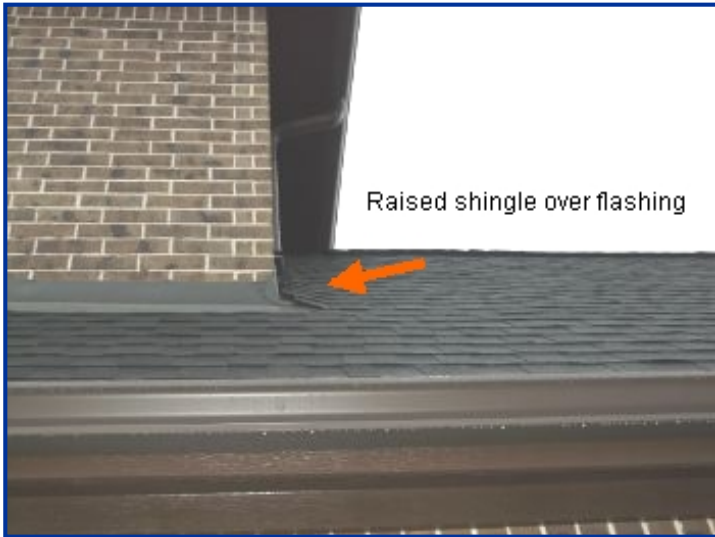
Left elevation lower roofing

- Raised shingles are evident in various locations of the roofing application, most notably in the left elevation (lower roofing) at the forward wall rake. Further evaluation recommended and repair as required to prevent water intrusion.

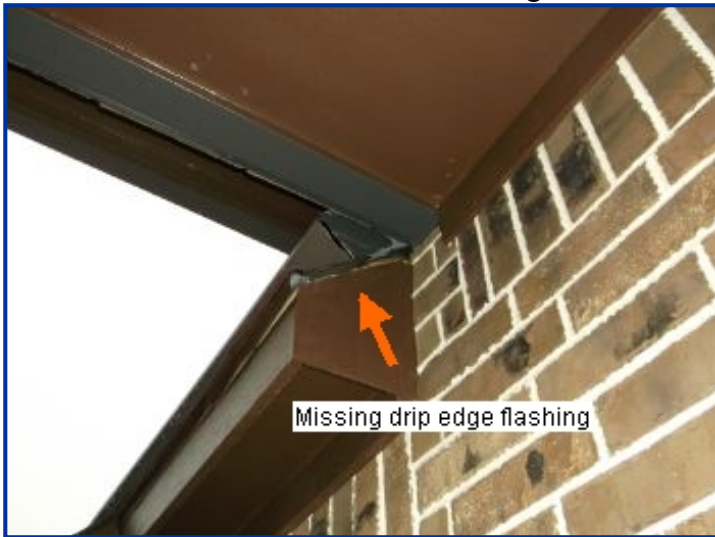
Roofing eyebrow over exterior door between garages

- Drip edge flashing is not installed in the "eyebrow" nearest the exterior door between the garages. Repairs recommended.
- Debris is present in several locations of the roofing. Cleaning recommended.

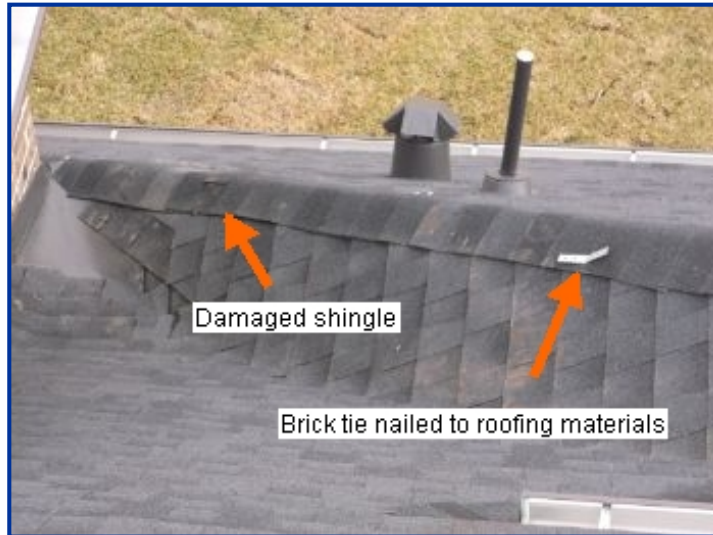
Lower left elevation roofing application

- A "brick tie" is fastened to the roofing materials and a hip shingle is split in the lower left elevation roofing materials. Repairs recommended to prevent potential for water intrusion.

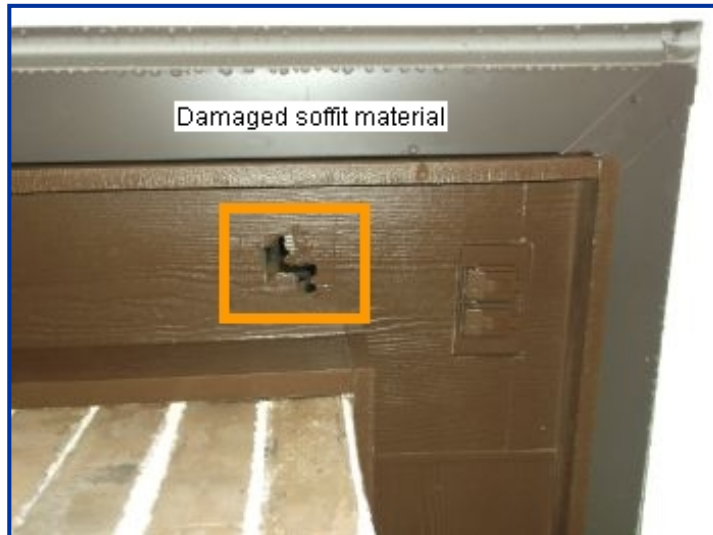
Left forward soffit corner

- Viewed From: Attics
- Ventilation observed: Soffit and Ridge
- All visible structural members appear to be functioning properly at time of inspection.
- Soffit materials are damaged (holes present) in the left forward corner eave. Repairs recommended.

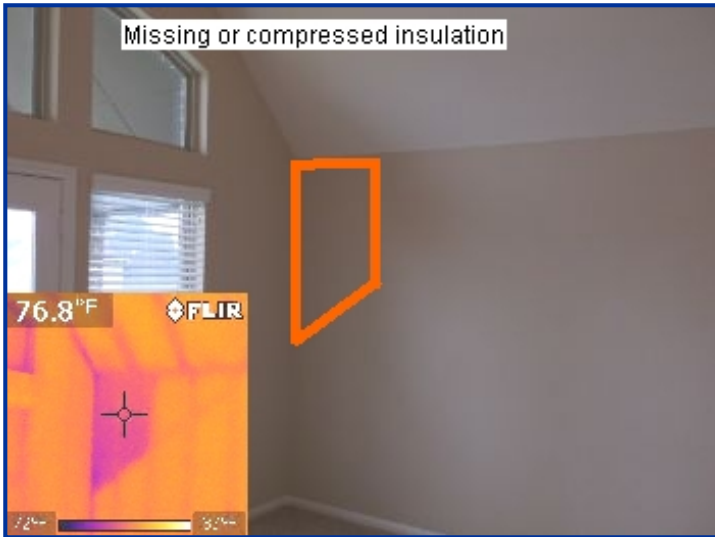
Right rear wall of upper game room

- Observed missing or compressed insulation at the rear of the upper game-room (right wall). Further investigation is recommended and repairs as needed to ensure thermal boundary.

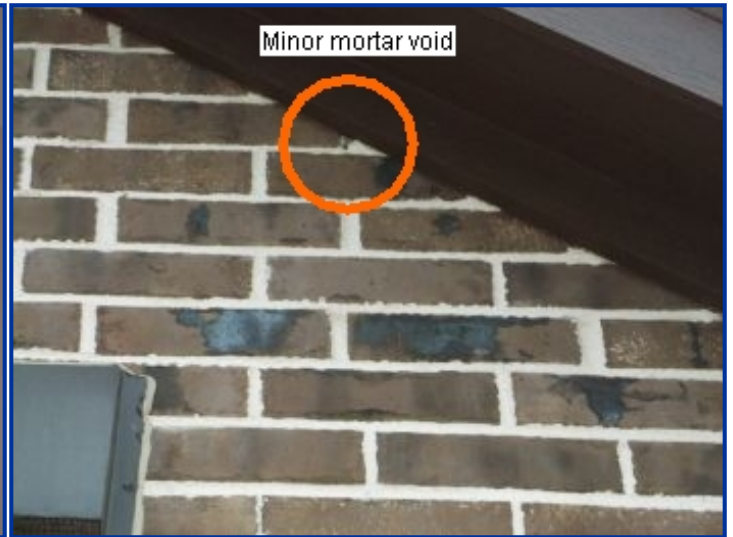
Right elevation over A/C compressors

- Minor mortar voids were observed in the exterior masonry veneer, most notably in the right elevation applications. Repairs recommended to prevent potential for moisture intrusion.

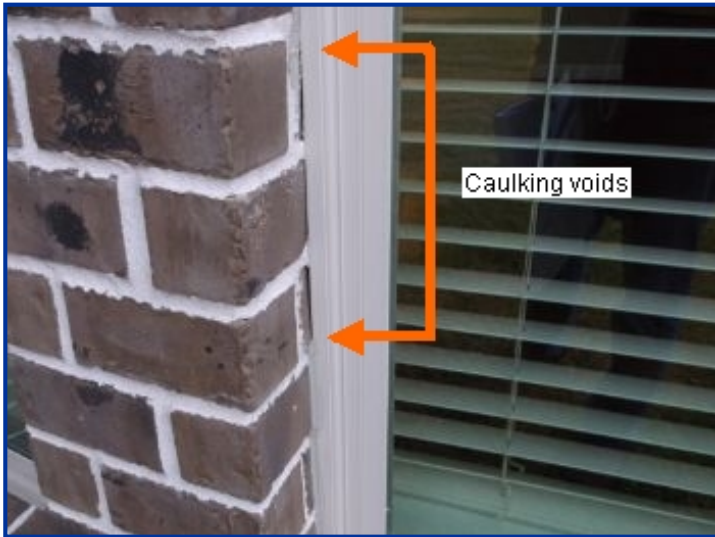
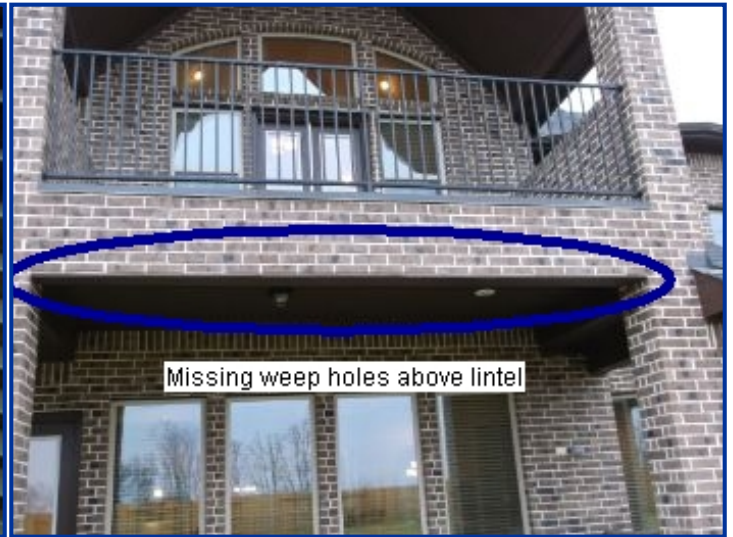
Masonry beneath upper rear porch

- Voids are present at various window frames. Caulking/sealing recommended to prevent potential for water intrusion.
- Weep holes are not installed in some areas, most notably beneath the upper rear porch and over the exterior door from the breakfast room. Weep holes are required to allow moisture to "weep" away if condensation forms on the back side of the brick and mortar. Repairs recommended.

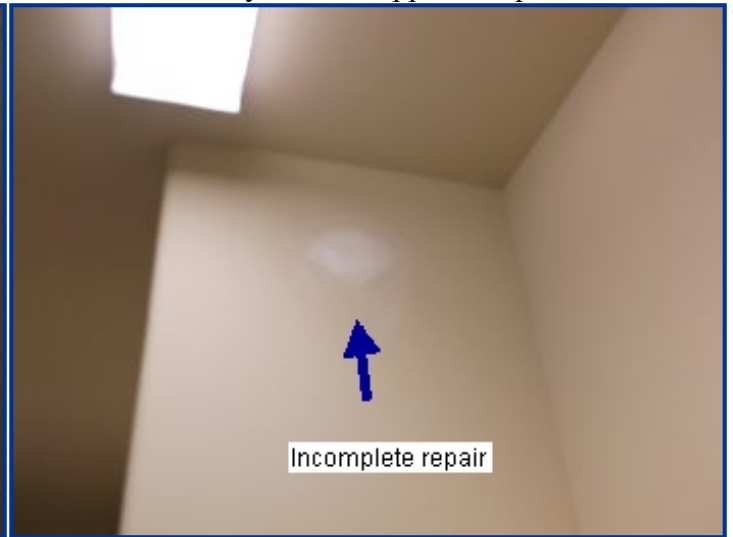
Master closet

- Incomplete repairs are present in the master closet sheetrock. Completion recommended.
- Water damage is present above the commode in the lower left powder bath. Further evaluation recommended and repairs as required to ensure further damage does not occur.

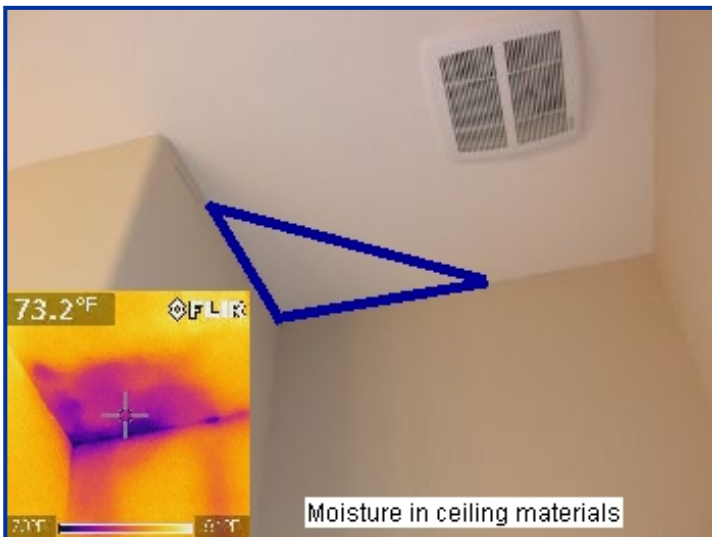
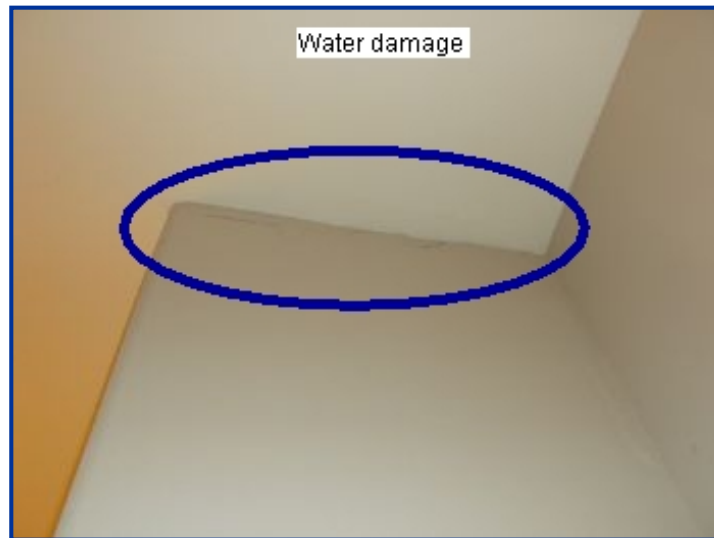
Ceiling over commode in lower left hall bath

- Water damage is present above the commode in the lower left powder bath. Further evaluation recommended and repairs as needed.
- Observed missing or compressed insulation in the upper game room left vault ceiling. Further investigation is recommended and repairs as needed to ensure thermal boundary.

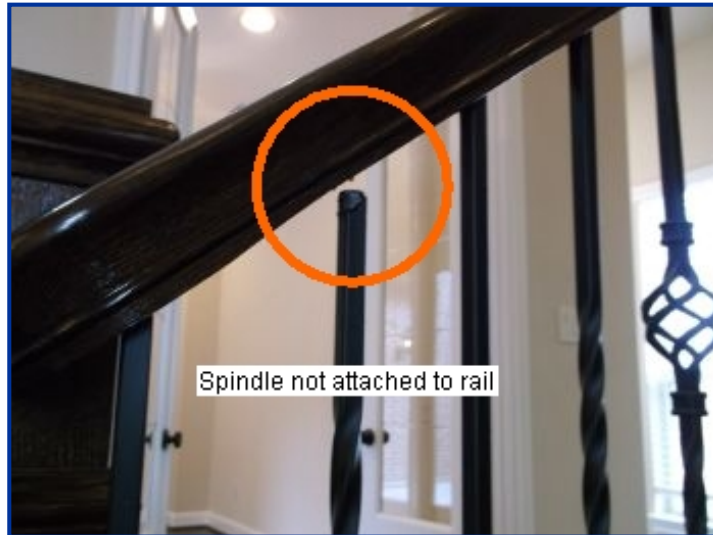
Base of curved stairs

- A spindle near the base of the curved stairs is not properly secured to the handrail. Repairs recommended for proper installation.

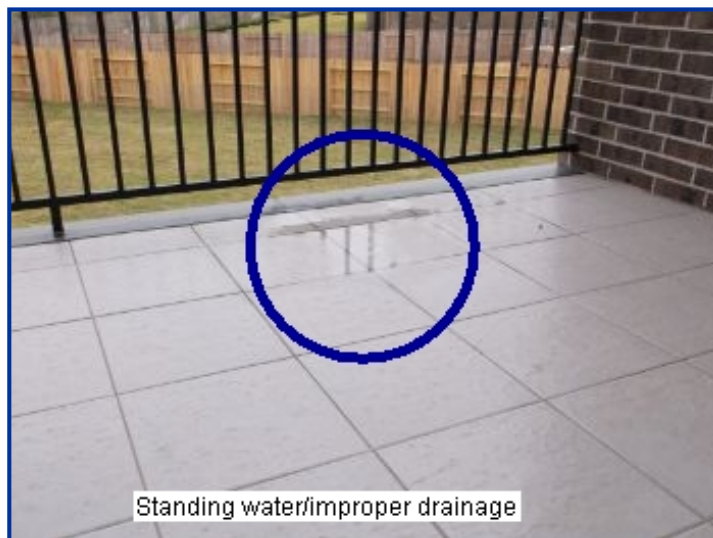
Upper rear porch

- The upper rear porch is improperly sloped to allow complete run off of rain water and moisture. Further evaluation recommended and repairs as needed.

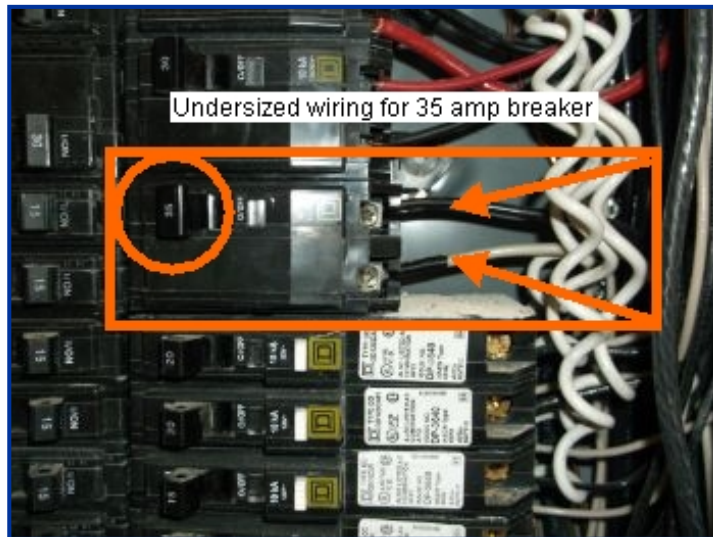
A/C breaker in main panel

- Due to the defects observed, recommend evaluation of breakers and wiring by licensed electrical professional and repair as required by current standards.
- The 35 amp A/C breaker for the 3.5 ton compressor is supplied by #10 AWG wiring. #10 AWG wire is only rated for up to 30 amps. The wiring for the A/C unit is undersized for the breaker supplying its power. Further evaluation recommended and repairs as needed.

Page 11 Item: A	Service Entrance and Panels	<ul style="list-style-type: none"> • The 35 amp A/C breaker for the 3.5 ton compressor is supplied by #10 AWG wiring. #10 AWG wire is only rated for up to 30 amps. The wiring for the A/C unit is undersized for the breaker supplying its power. Further evaluation recommended and repairs as needed.
Page 12 Item: B	Branch Circuits, Connected Devices, and Fixtures	<ul style="list-style-type: none"> • A concrete encased grounding electrode (UFER) is installed. These systems are only applicable when the foundation concrete is in direct contact with bare earth. Typical slab foundation installations require a moisture/vapor barrier which void this installation. Further evaluation recommended and repairs as needed. • The outlet forward of the fencing in the right elevation exterior is inoperable. Repairs required for proper operation. • Light fixture(s) in the home is/are inoperable, most notably over the kitchen island. If the bulb(s) are not blown, the circuit should be investigated and repaired as needed for proper operation. • The (lower) GFCI outlet in the forward wall of the outdoor kitchen is installed with an open neutral and is not properly tripping when tested. Repairs required for proper function. • The switches for the hall lighting at the top of the curved stairs are wired incorrectly. The left switch is inoperable when the right switch is in the "off" position. Repairs required for proper function. • The outlet installed rear of the exterior doors in the study appears to be overheated when observed with thermal imaging. Further evaluation recommended and repairs as needed for proper safety. • The outlet installed for the upper rear porch was not able to be tested as it would not accept the three prong plug end of testing equipment. Further evaluation recommended and repairs as needed for proper operation.

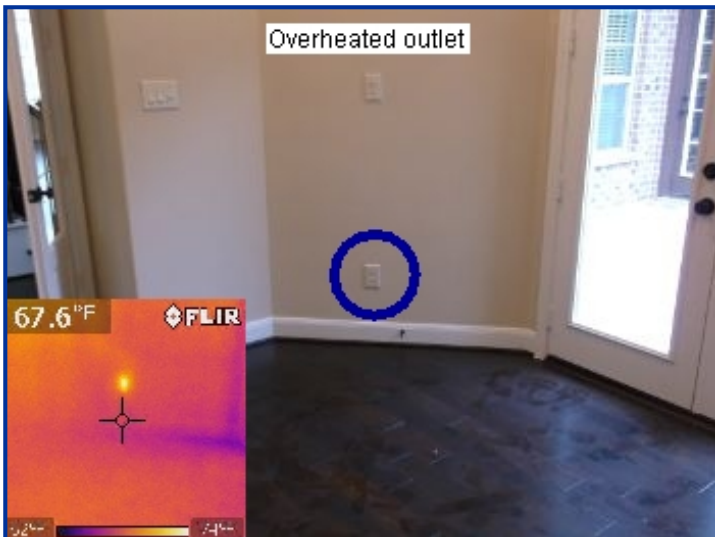
Left rear wall of study

- The outlet installed rear of the exterior doors in the study appears to be overheated when observed with thermal imaging. Further evaluation recommended and repairs as needed for proper safety.

Overheated outlet

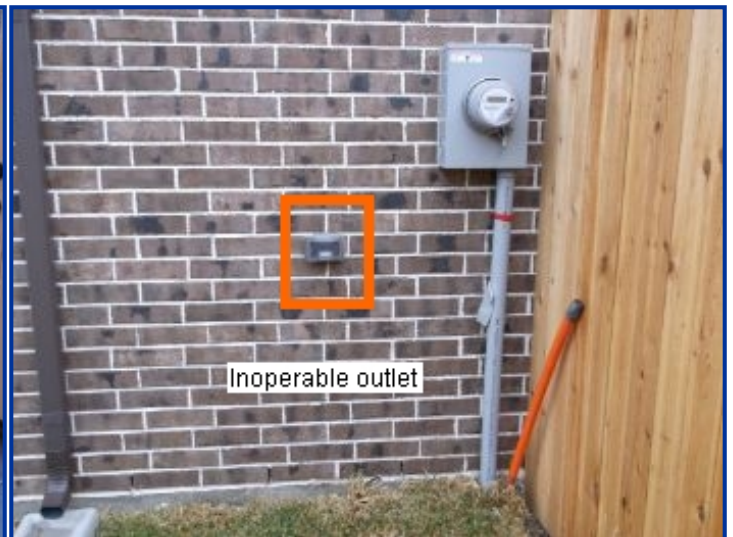
Right forward elevation

- The outlet forward of the fencing in the right elevation exterior is inoperable. Repairs required for proper operation.
- Light fixture(s) in the home is/are inoperable, most notably over the kitchen island. If the bulb(s) are not blown, the circuit should be investigated and repaired as needed for proper operation.

Inoperable outlet

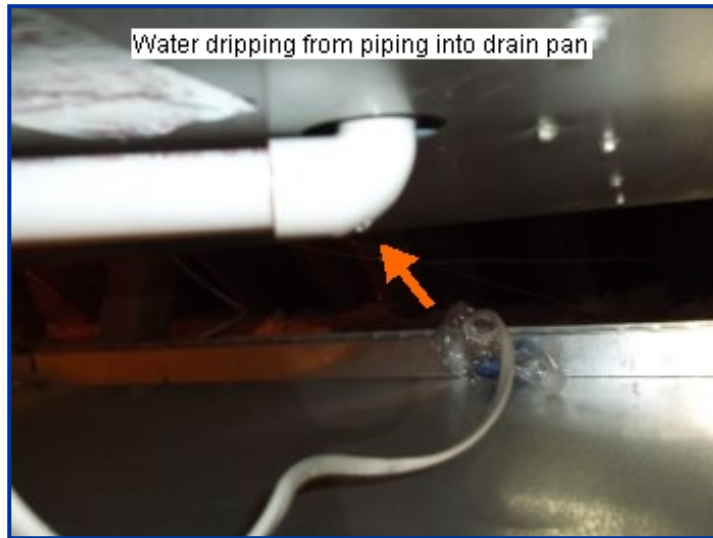
Left rear furnace unit

- Water is dripping from piping beneath both furnaces installed in the left elevation of the attic. Further evaluation recommended and repairs as needed.

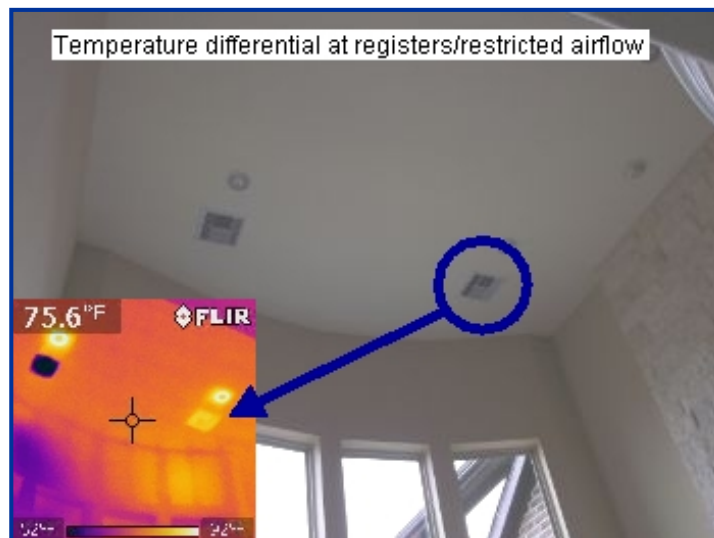
Living room (left of fireplace)

- Comments:
- The right side register in the (left) living room indicates restricted airflow as evidenced with thermal imaging (see photo). Further evaluation recommended and repairs as needed.

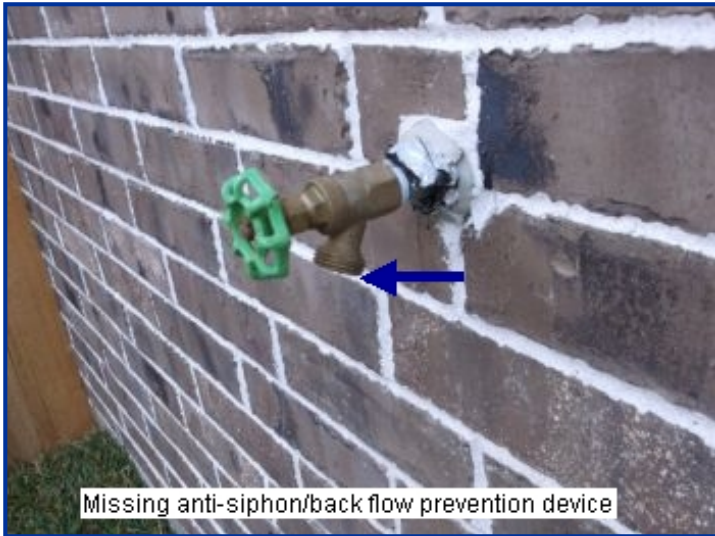
Left elevation hose bib

- The valve for the right elevation hose bib leaks during operation. Repairs may be desired.
- Anti-siphon/back-flow prevention device(s) are not installed on exterior faucet(s) located in the left elevation. Repairs recommended for proper safety.
- Minor chips are present in the finish of the steel tub in the upper "jack & jill bath". Repairs may be desired.
- The shower pan in the lower left hall bath is damaged/chipped. Repairs may be desired.
