# ***Punch Inspection Services*** **Property Inspection Report**

1313 Mockingbird Lane, Spring, TX 773XX  
Inspection prepared for: Warranty Client  
Date of Inspection: 1/1/2015 Time: 9:00 am  
Age of Home: 2014 Size: 3500 sq/ft  
Weather: Clear  
Temperature at arrival: 62 Degrees  
House face: Southwest  
Occupancy: Occupied

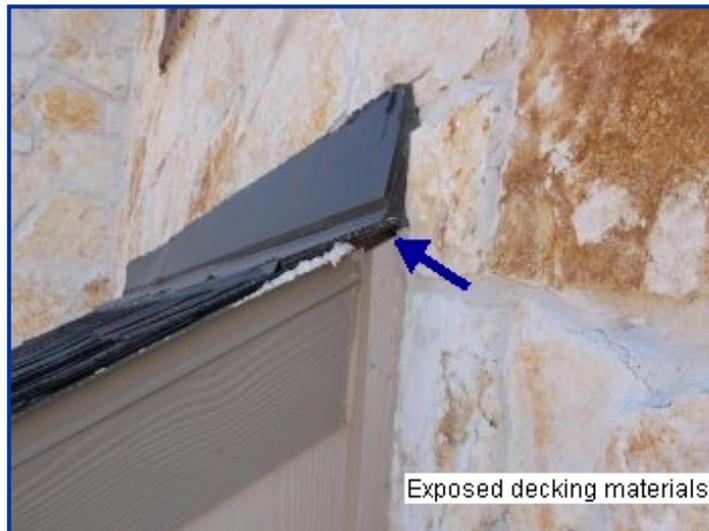
- Note: Not all roofing applications are walked on during the inspection due to slope of roof, weather and other safety concerns. Weather conditions, wind, hail and extreme temperatures affect all roofing from day to day. Continual observation is recommended. (Roofs are not checked for insurability; this is due to the fact that different insurance companies have different standards for insuring homes.
- Voids are present and decking is exposed over the boxed window in the front elevation. Repairs recommended to prevent potential for water intrusion.

Front elevation box window

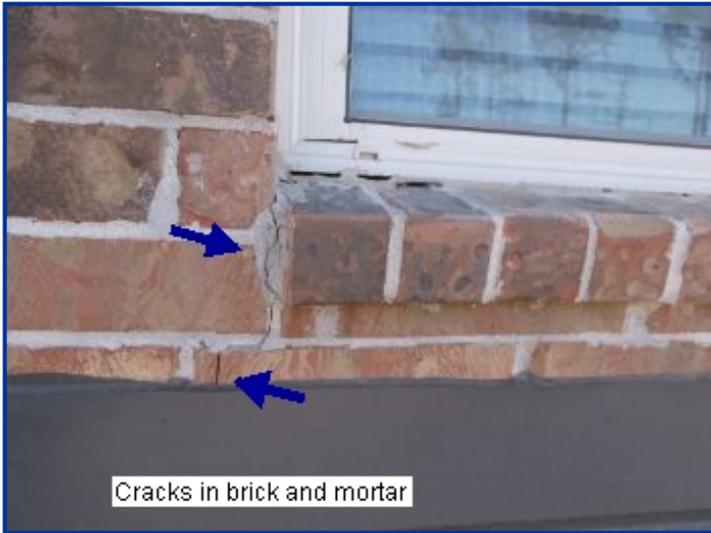
Left window above garage

- Gaps are present between the brick veneer and the left window over the garage. Further evaluation recommended and repairs as needed.
- Siding is bowing and voids are present in vertical butt joints in the left (upper) exterior wall. Further evaluation recommended and repairs as needed.

Cracks in brick and mortar

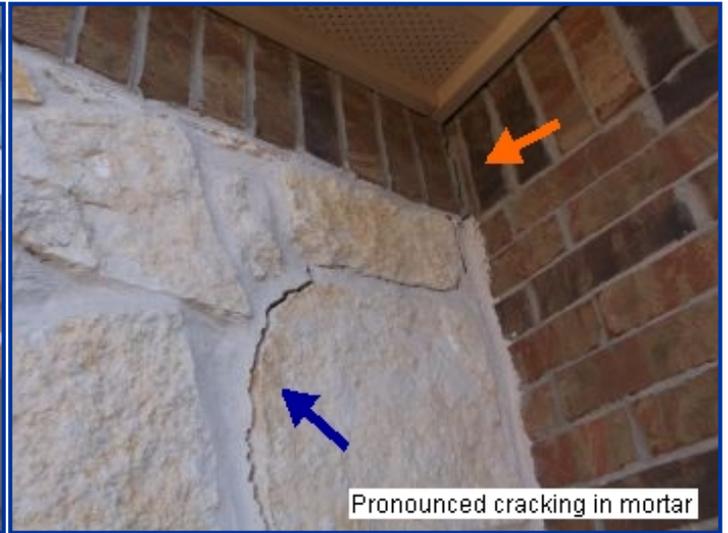
Upper wall above garage/front porch

- Pronounced cracks in the mortar were observed in the exterior masonry veneer, most notably in the walls above the garage and the post bases in front of the garages. This condition indicates significant movement in the wall. Further evaluation recommended by a qualified specialist to ensure the wall(s) is/are properly supported to the foundation and not resting on roof framing and decking materials.

Pronounced cracking in mortar

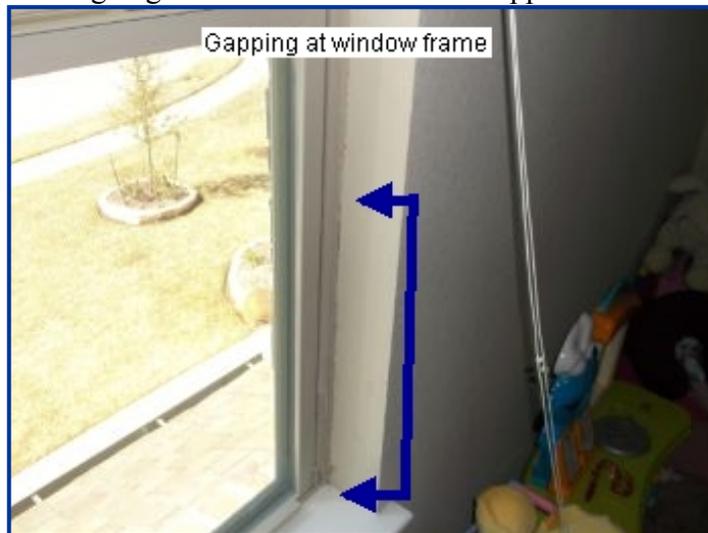
Game room (left window)

- Sheetrock damage was observed near the light switch in the rear of the one (1) car garage. Repairs may be desired.
- Gaps are present between the sheetrock and window frame of the left window in the upper game room. Further evaluation recommended and repairs as needed.

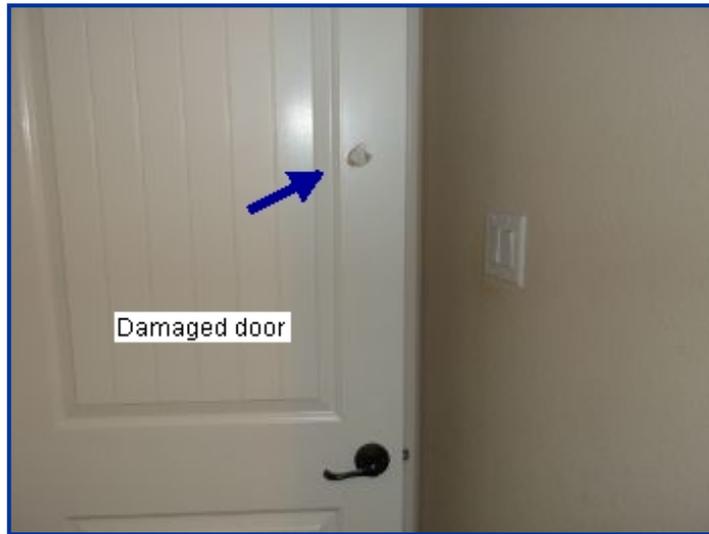
Upper rear left bedroom

- The upper left rear bedroom entry door is damaged. Repairs recommended.

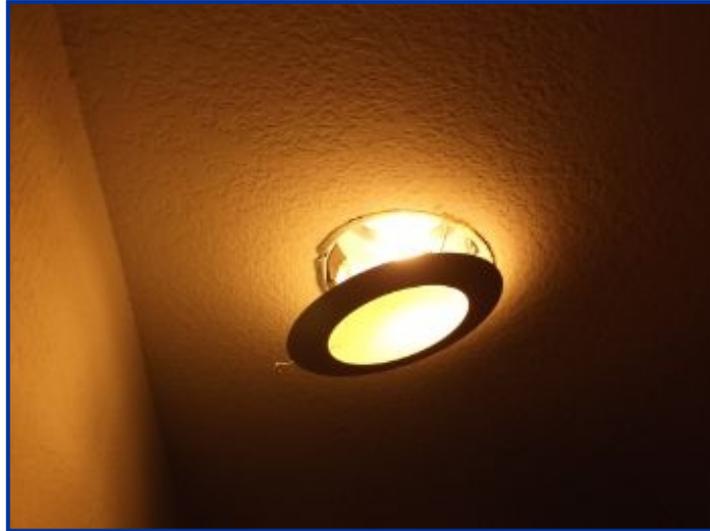
Fixture in upper front left bedroom

- The recess light trim in the upper front left bedroom closet is loose and the bulb is exposed. Repairs recommended for proper safety.
- Loose wiring is present in the lower attic as work is in progress. Adding staples/securing recommended for proper safety.

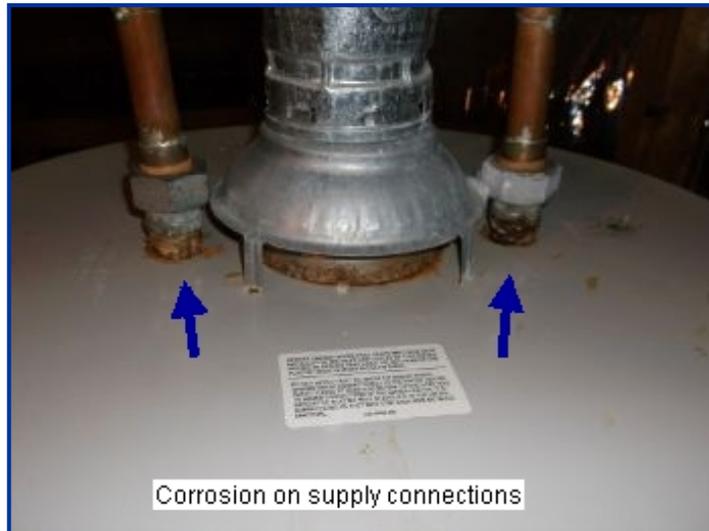
- The water temperature was measured at 118 degrees which is within acceptable limits for safety.
- Supply fittings for the water heater have corrosion present. Further evaluation recommended to ensure proper installation and repairs as needed.

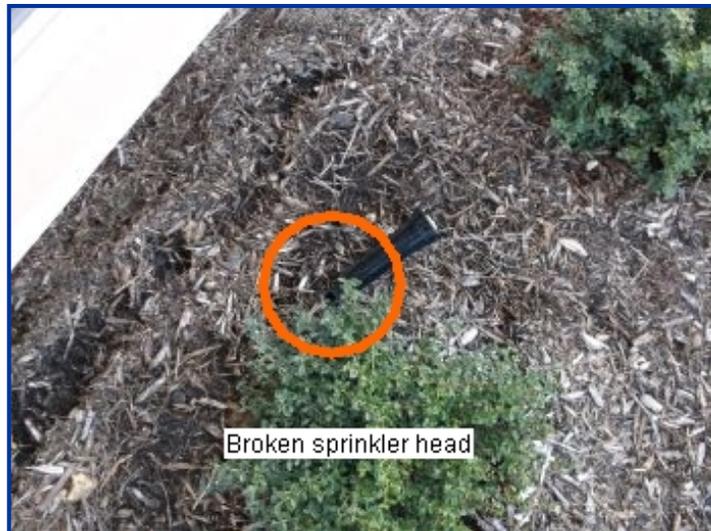
Front flower bed

Comments:  
 • Hunter Brand  
 • 12 Zone System  
 • Due to the defects observed, recommend complete evaluation by irrigation contractor.  
 • Note: Zones 9 and 10 appear to be modified around the pool.  
 • A head in the front middle flower bed is broken. Repairs recommended for proper function.
