Punch Inspection Services **Property Inspection Report**

4321 Rodeo Drive, The Woodlands, TX 77XXX
Inspection prepared for: Punch Frame Demo
Date of Inspection: 4/18/2015 Time: 11:00 am
Age of Home: 2015 Size: 4,167 sq/ft
Weather: Overcast/Rain
House faces: West
Temperature at arrival: 76 Degrees
Occupancy: Vacant

PROPERTY INSPECTION REPORT

Concerning: 4321 Rodeo Drive, The Woodlands TX, 77XXX
 (Address or Other Identification of Inspected Property)

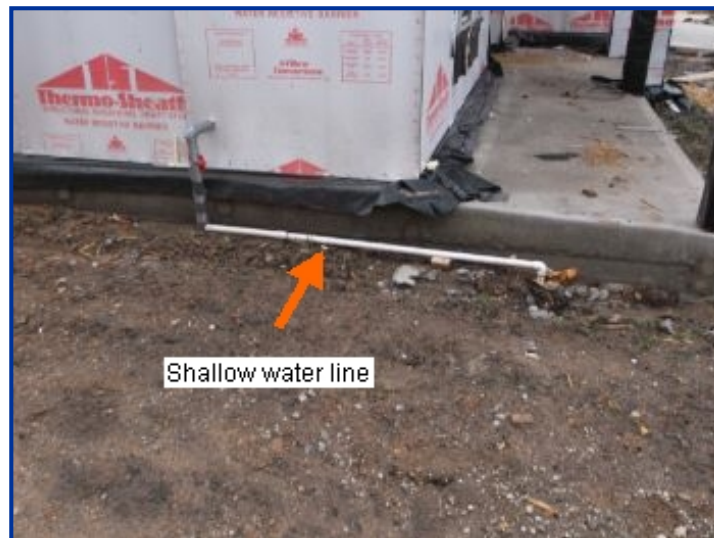
- Note: The master bath and upper level (left) bath tubs are not present/installed during this inspection.
- The main water line is installed at an incorrect depth. Water lines should be installed a minimum of 18" below grade. Repairs recommended.
